MAGNUM

Client: Ms. Chinese Sample

Date: January 15, 2011

Chinese Drywall Inspection

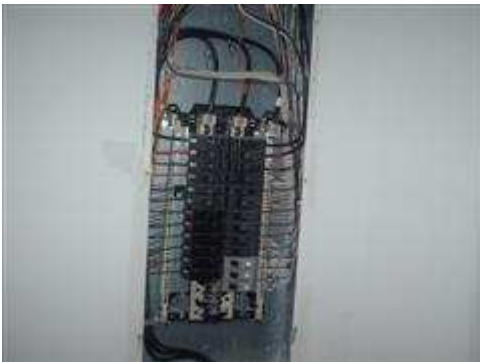
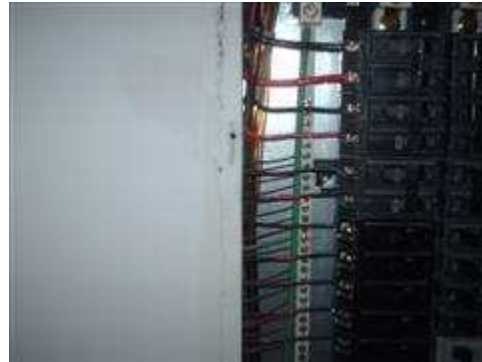
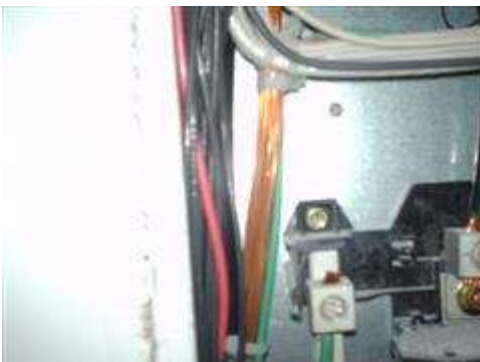
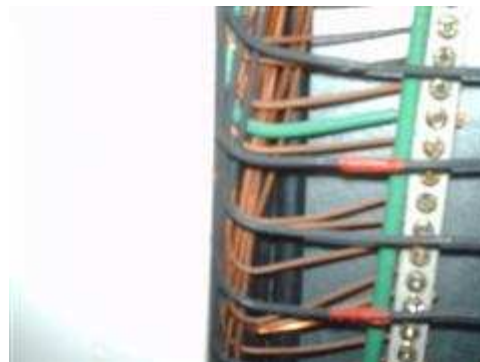
1. Drywall manufactured in China "Chinese Drywall" was observed in the attic.
2. Drywall manufactured in China "Chinese Drywall" was observed at the wall void in the upstairs bathroom.
3. Discoloration was observed on the air handler coils.
4. No discoloration observed on the electrical components inspected.
5. Home appears to be plumbed with PVC and is not affected.

1. The home does have "Chinese Drywall" in the attic and walls.
2. The air handler has been affected by the "Chinese Drywall".
3. The electrical system does not appear to have been affected by the "Chinese Drywall".

Copper ground wires observed in kitchen breaker panel.

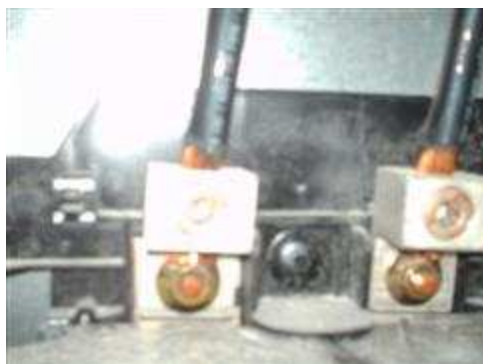
Main lugs and wiring in kitchen panel.

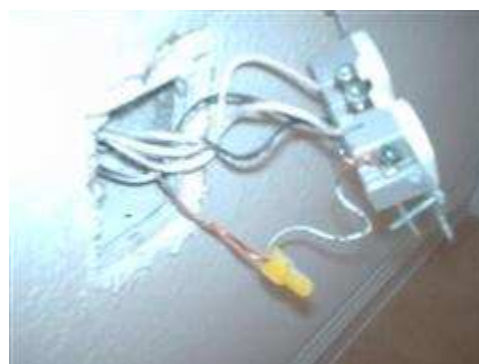
Receptacle wiring observed in living room.

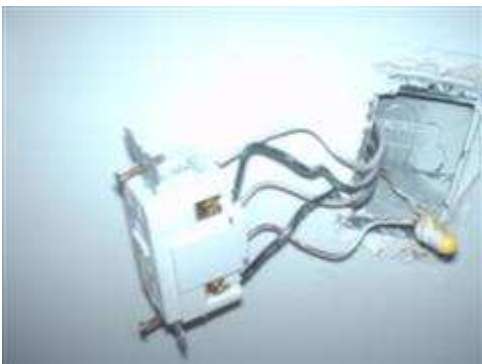
G.F.I. receptacle wiring observed in downstairs bathroom.

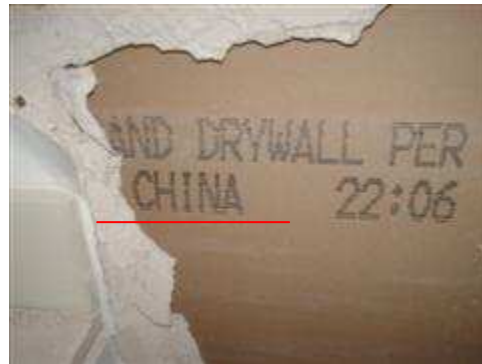
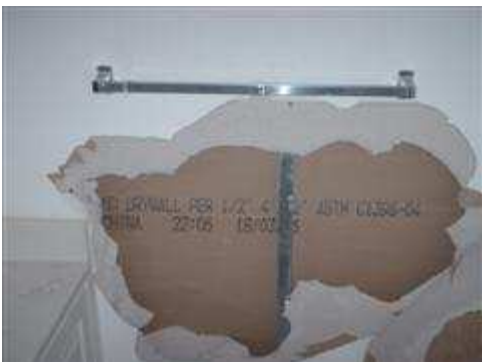
Chinese drywall observed in upstairs rear bathroom,.

- ALL Drywall and insulation be removed and replaced. This will require removal and replacement of the interior components (cabinets, vanities, fixtures, etc.)
- The air handler and lines to be replaced.

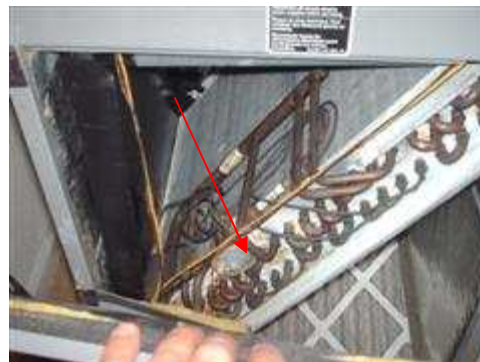
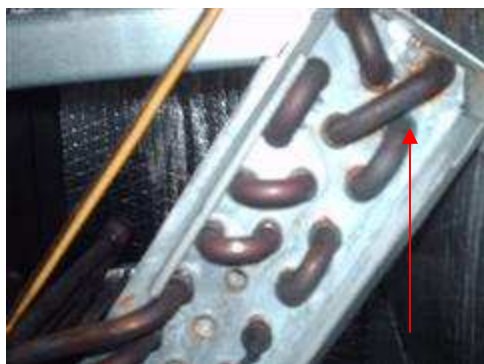
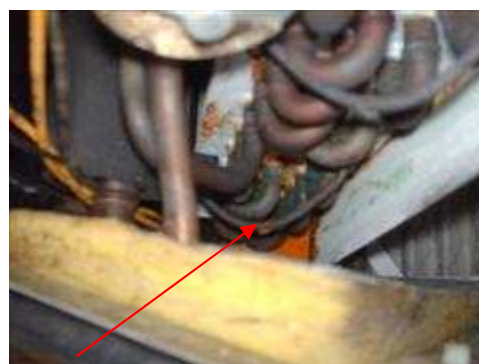
Air handler coils were corroded.

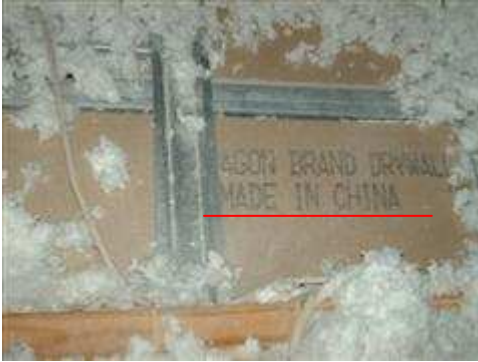
Chinese drywall observed in attic.
