Property Inspection Report

**Type of building:** Single family

**Age of building:** Approximately 53 Years Old

**Foundation type:** Slab on grade

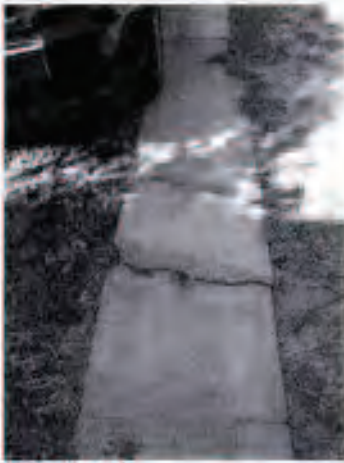
**Photo 1**

One or more trip hazards were found in the driveway due to cracks, settlement and/or heaving. Recommend having a qualified contractor evaluate and repair or replace driveway sections as necessary to eliminate trip hazards.

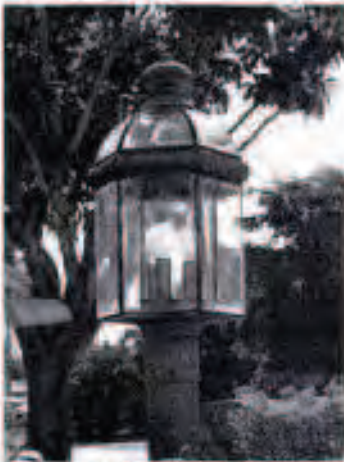
**Photo 40**

One or more light fixtures are loose or installed in a substandard way. A qualified contractor or electrician should evaluate and make repairs as necessary so light fixtures are securely mounted and installed in accordance with the manufacturer's installation instructions.

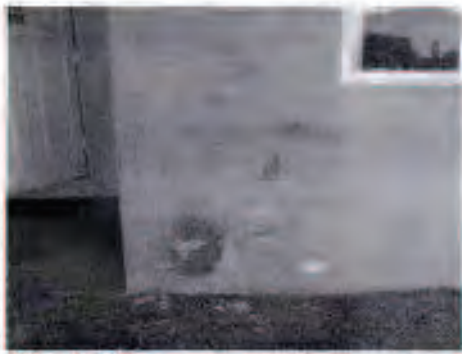
**Photo 3**

Cracks, deterioration and/or damage were found in one or more areas of the stucco siding. A qualified contractor should evaluate and make repairs and/or replace stucco siding as necessary.

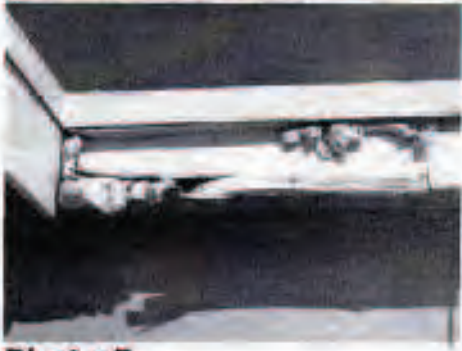
**Photo 5**

- 
- 10) 🔍 Rot was found in one or more areas. A qualified contractor should evaluate and repair as necessary. All rotten wood should be removed or replaced.

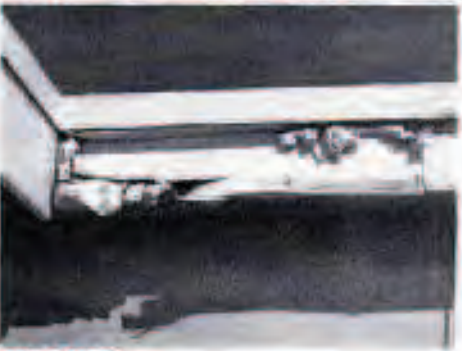
**Photo 5**

- 
- 11) 🔍 Rot was found in one or more areas on soffit boards. A qualified contractor should evaluate and make repairs as necessary, replacing all rotten wood.

- 
- 12) 🔍 Fascia boards are damaged or deteriorated in one or more areas. A qualified contractor should evaluate and make repairs as necessary.

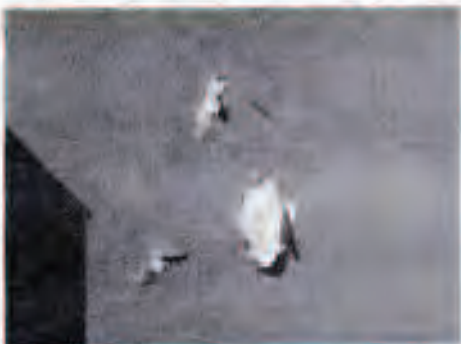
**Photo 7**

**21)** ↘ The exterior finish in some areas is falling. A qualified contractor should prep (pressure wash, scrape, sand, prime caulk, etc.) and repaint or restrain areas as needed and as per standard building practices.

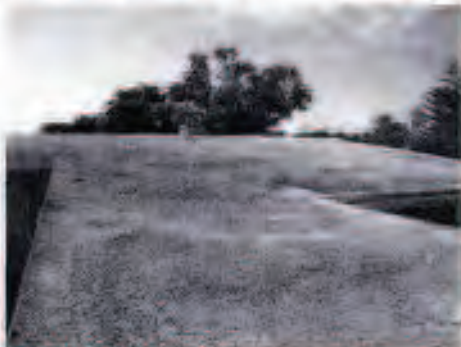
Photo 19

The roof surface material appears to be near the end of its service life and will likely need replacing in the near future, even with repairs. The client(s) should budget for a replacement roof surface, and may want to have a qualified roofing contractor evaluate and attempt to issue a "5 year roof certificate".

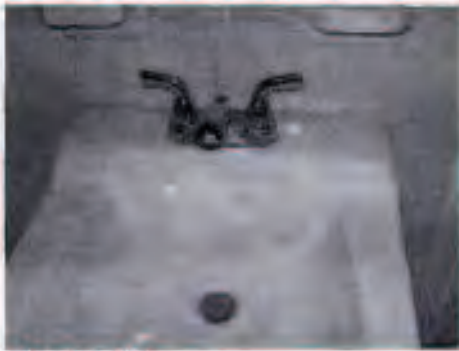
**Photo 26**

**50)** 🔍 One or more sinks is loose, or not securely attached to the wall behind it. A qualified contractor should evaluate and repair as necessary.

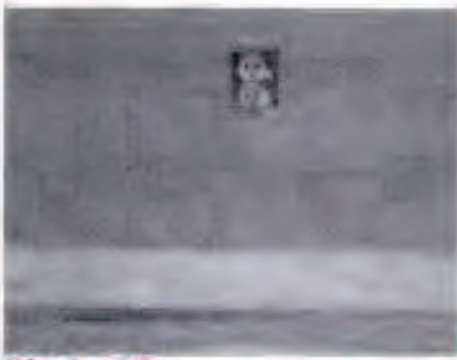
**Photo 25**

**59) ⚡🔍** Cover plate(s) are missing from one or more electric boxes, such as for receptacles, switches and/or junction boxes. They are intended to contain fire and prevent electric shock from exposed wires. This is a safety hazard due to the risk of fire and shock. Cover plates should be installed where missing.

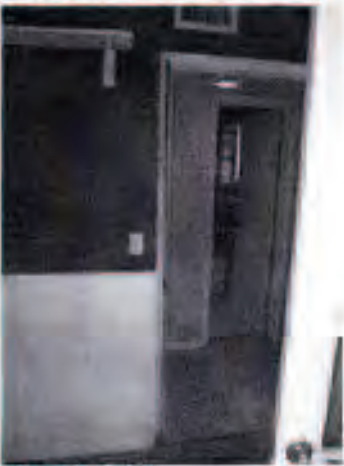
**Photo 22**

**63)** 🔍 One or more interior doors are damaged and/or deteriorated and should be repaired or replaced by a qualified contractor.

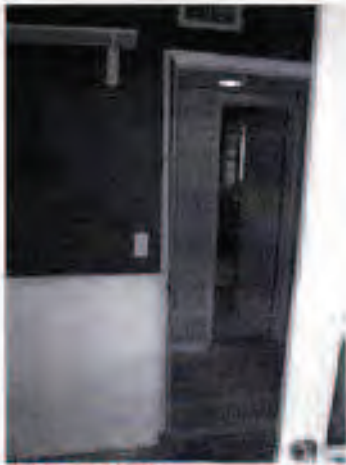
Photo 22

**64)** 🔍 Trim is missing in one or more areas. Recommend having a qualified contractor install trim where missing.

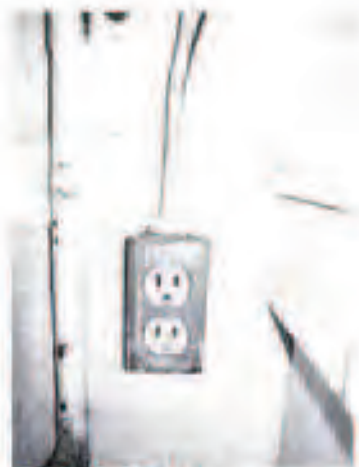
**Photo 15**  
improper wiring

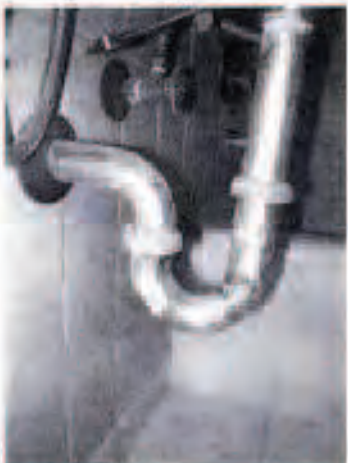
**Photo 32**  
pipes deteriorating

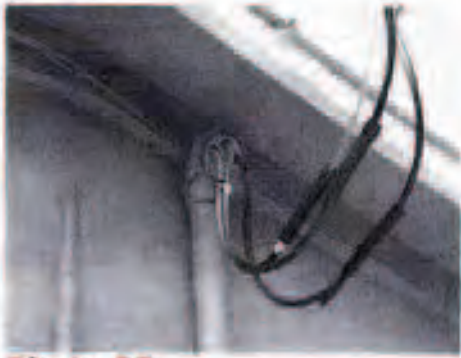
No drip loop is installed in the service entrance wires. Water may enter the service entrance conduit and equipment as a result. A qualified electrician should evaluate and repair as necessary.

**Photo 35**  
No drip loop
