[www.magnuminspections.com](http://www.magnuminspections.com)

Phone: (954) 340-6615

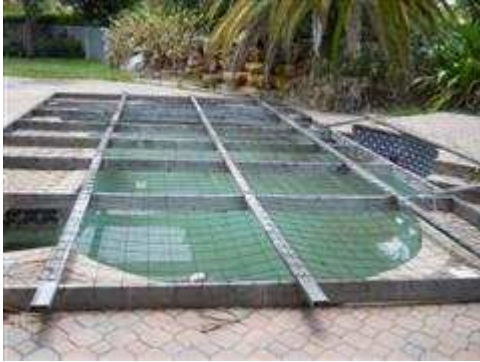
The swimming pool was not in a condition where it could be inspected.

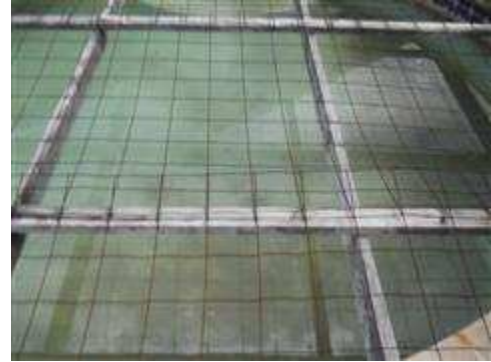
The swimming pool was not in a condition where it could be inspected.

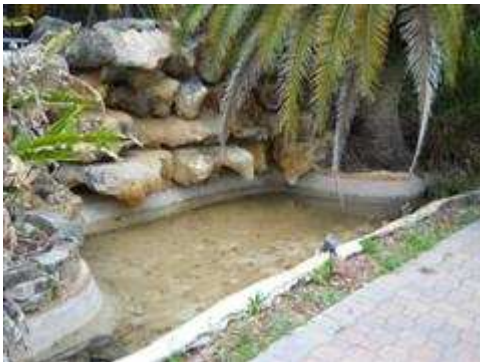
The swimming pool was not in a condition where it could be inspected.

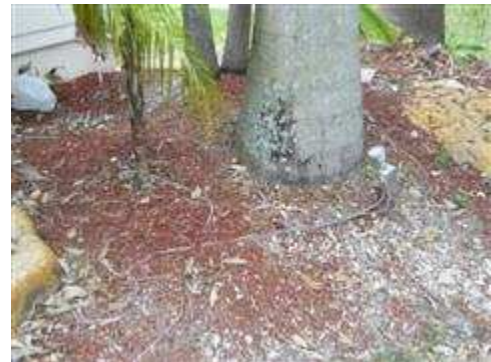
Exposed wiring observed in numerous areas of the yard for the landscape lighting.

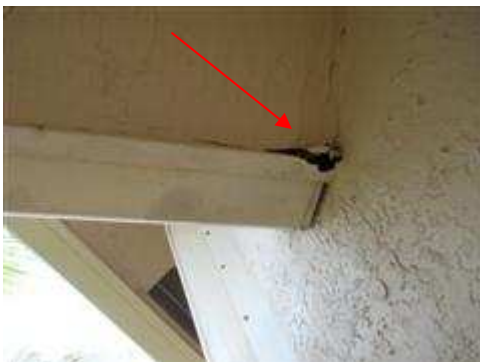
Roof leak observed at front entrance with damaged fascia.

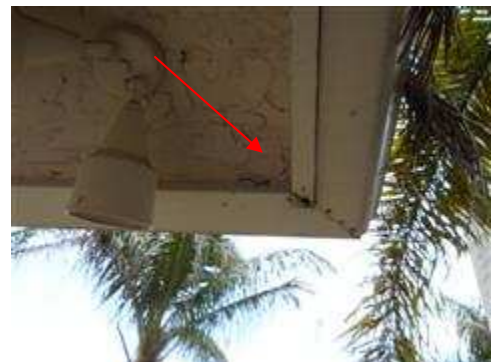
Damaged fascia observed at right front corner of house.

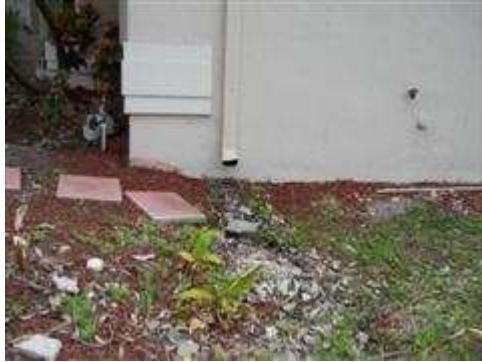
Improperly terminated gutter downspout at right side of house has washed away a large amount of soil.

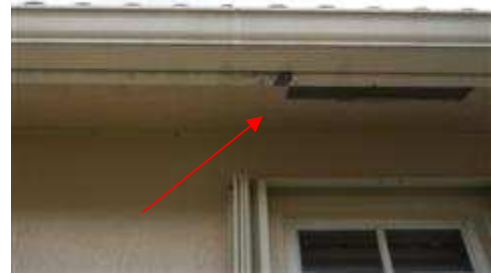
Damaged fascia observed at right side of house.

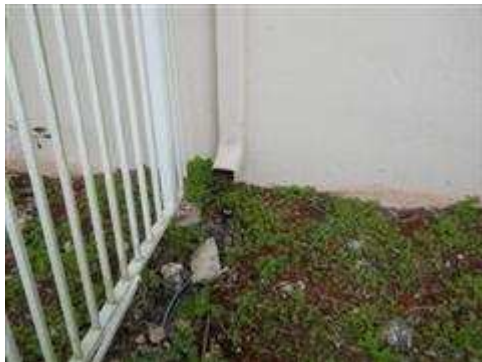
Improperly terminated gutter downspout at right side of house has washed away a large amount of soil.

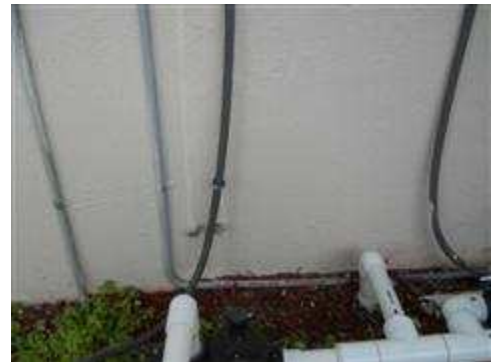
Conduit for pool equipment was not secured properly.

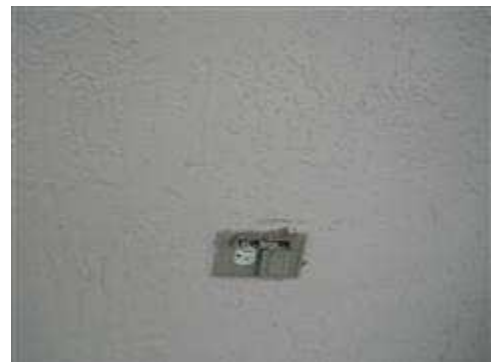
Receptacle at rear patio had a broken cover.

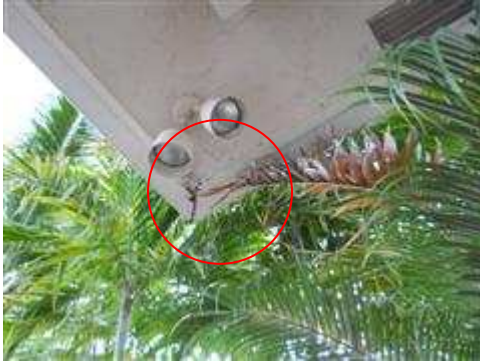
Damaged fascia observed at right rear corner of house.

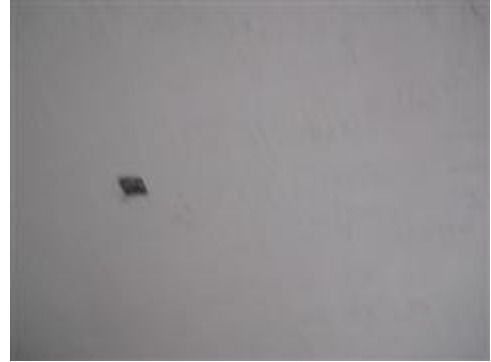
Exposed wiring observed at rear patio.

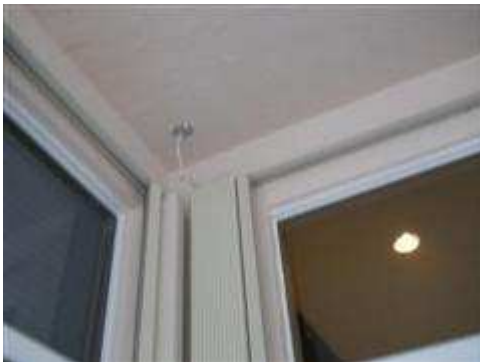
Exposed wiring observed at rear patio.

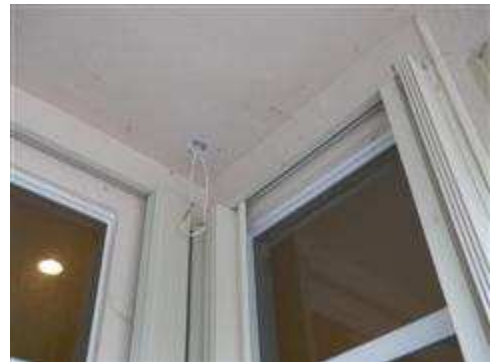
Exposed wiring observed at rear patio.

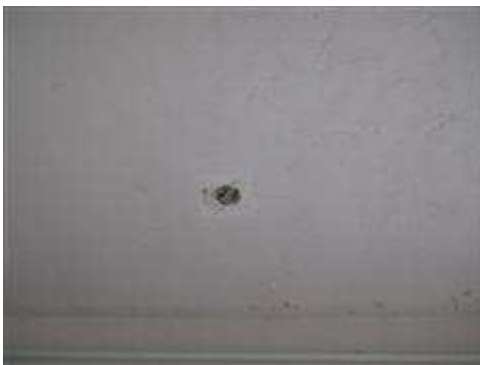
Exposed wiring observed at rear patio.

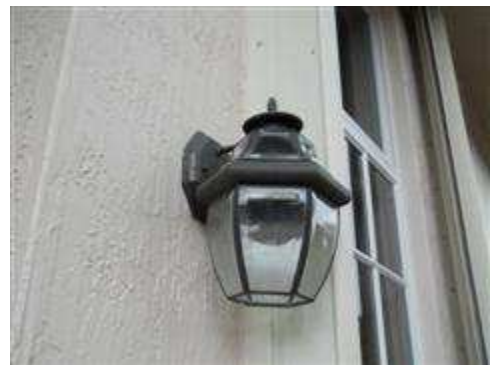
Rear patio light fixture was not secured/sealed properly.

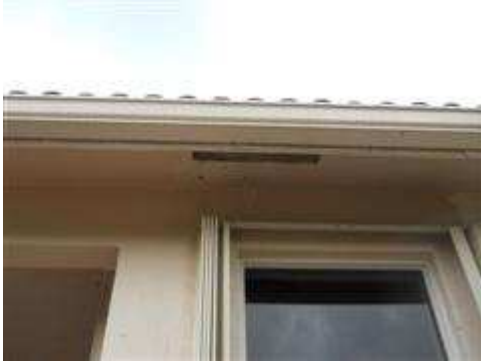
Exposed wiring at rear of house.

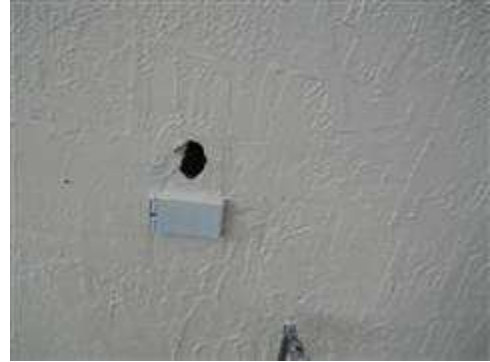
Damaged wall observed at rear patio.

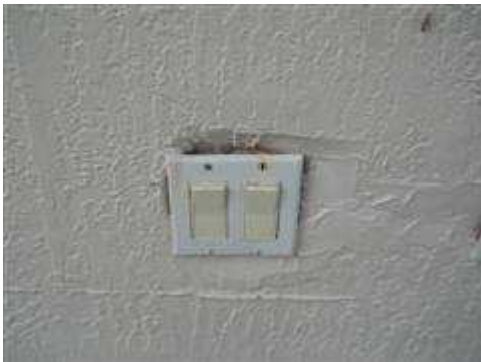
Damaged wall observed at rear patio.

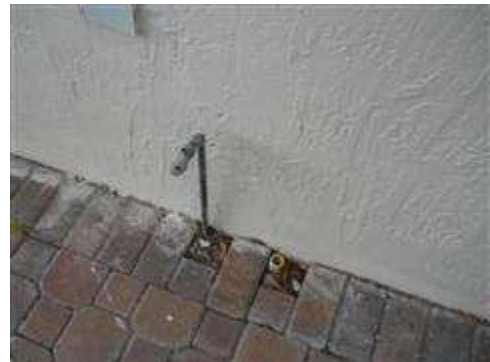
Plumbing line at rear of home was not secured.

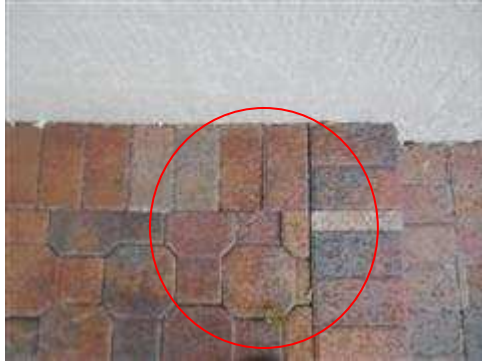
The landing area at the rear patio shower had several pavers which sunk when stepped on.

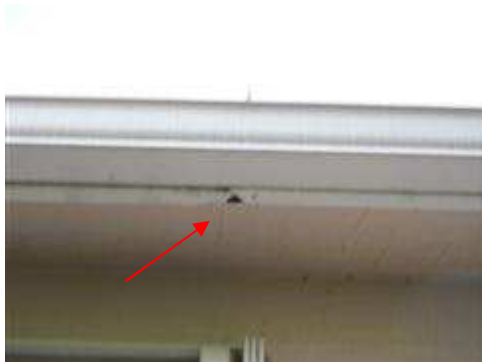
Damaged fascia observed at left side of house.

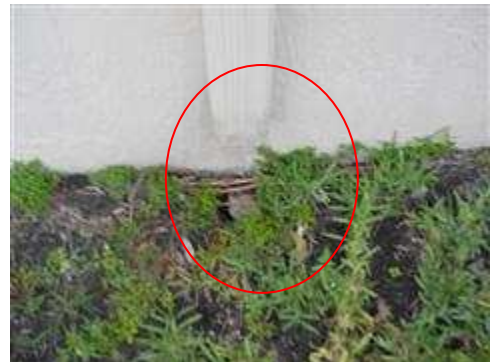
Missing gutter downspout which has caused the soil to erode at the left side of the house.

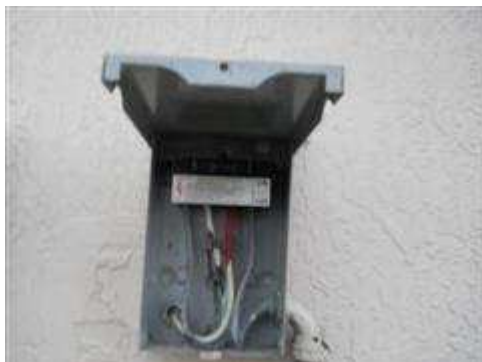
Inner cover plate was not present at two a/c condensing unit disconnects exposing the lugs and wiring.

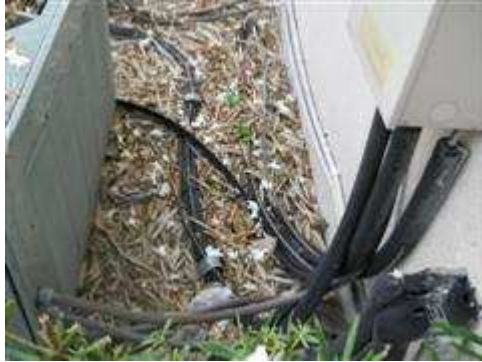
Insulation was damaged at the refrigerant lines for the a/c condensing units.

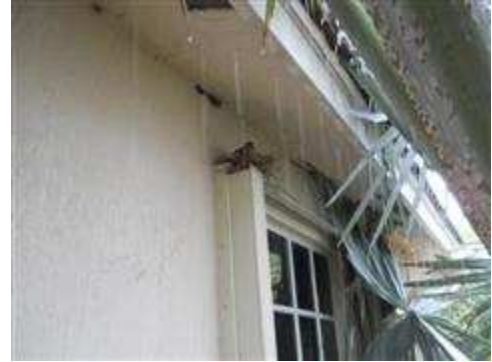
Tree at the left side of the home was up against the house and interfering with the roof.

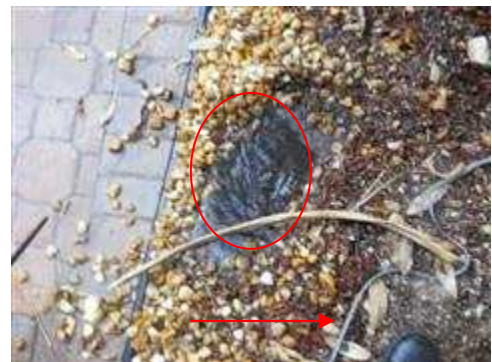
Exposed wiring observed in numerous areas of the yard for the landscape lighting. Several sprinkler heads were not present.

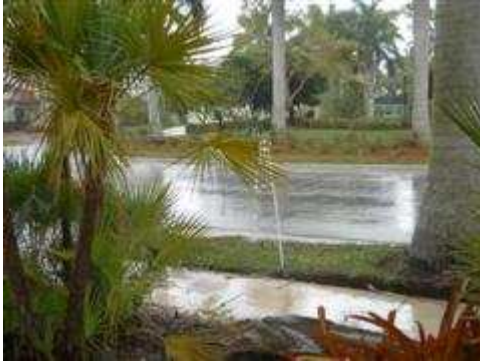
Several sprinkler heads were not present.

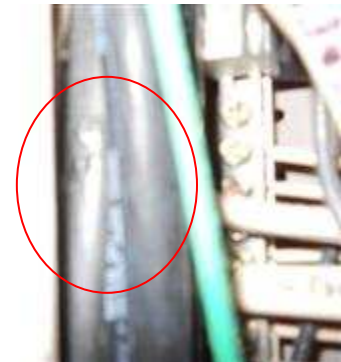
Damaged insulation observed to the panel box feed lines in both panels behind the dead front cover retaining screws.

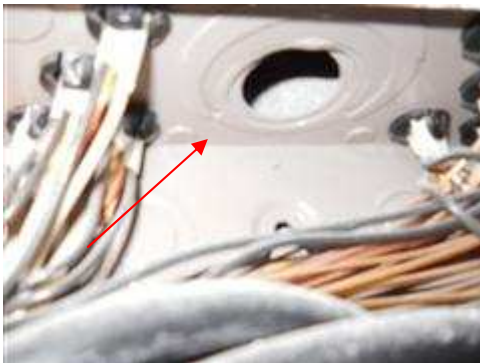
Void observed in garage breaker panel.

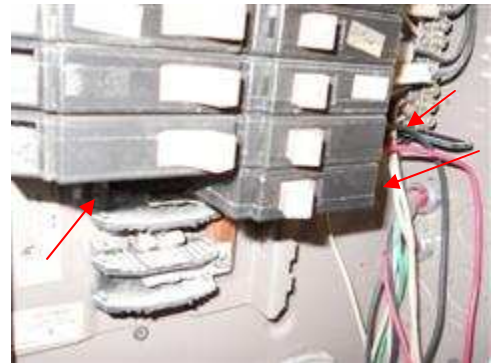
. Several breakers were not labeled at the garage panel.

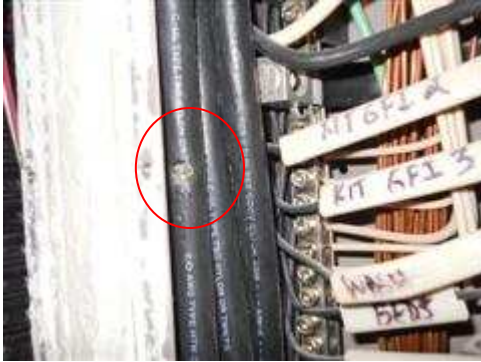
Damaged insulation observed to the panel box feed lines in both panels behind the dead front cover retaining screws.

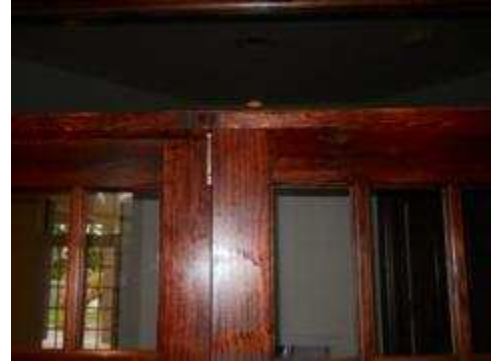
Front "den" door did not close.

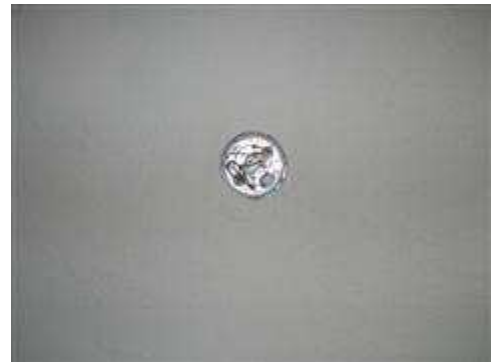
Missing light fixtures in den exposing wiring.

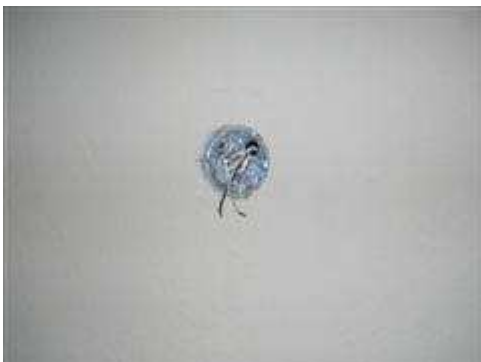
Missing light fixtures in den exposing wiring.

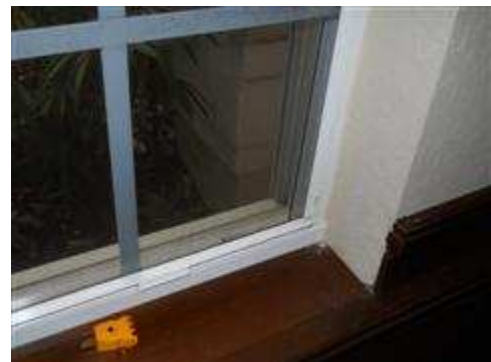
Window in den did not stay open (springs).

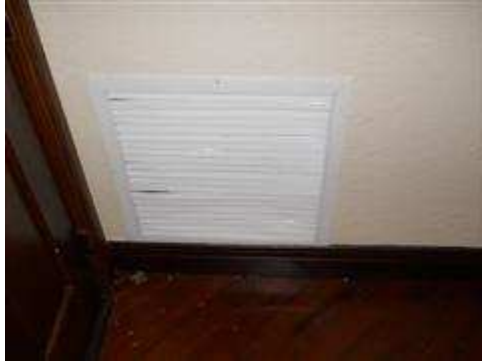
Intake grill in the master bedroom was installed in a manner that when the door is open, the flow to the unit is blocked.

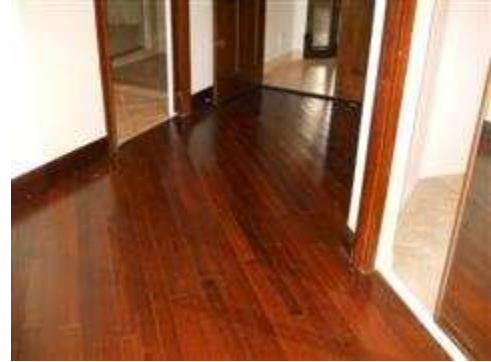
The flooring in the master bedroom was damaged from an apparent water leak, possibly from the air handler.

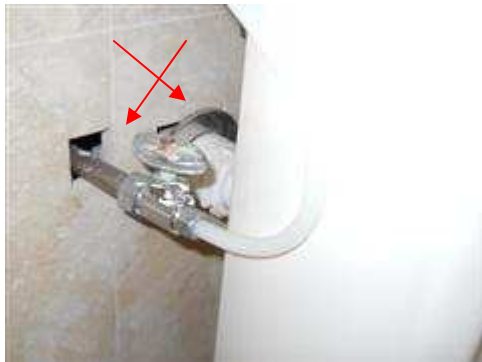
Shut off valves for "Cabana" bathroom sink were not secured.

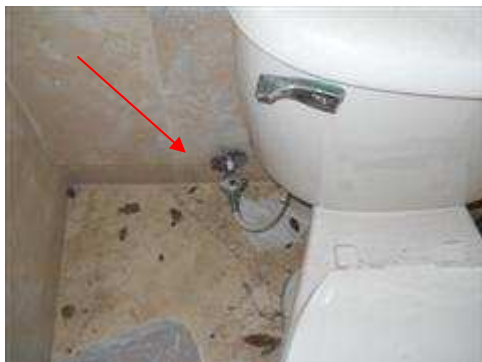
Shut off valve for toilet in Cabana bathroom was leaking.

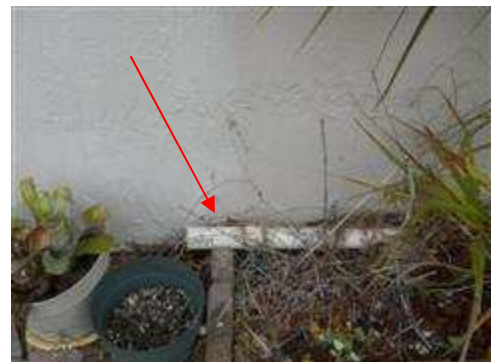
Uncapped drain line observed at rear patio.

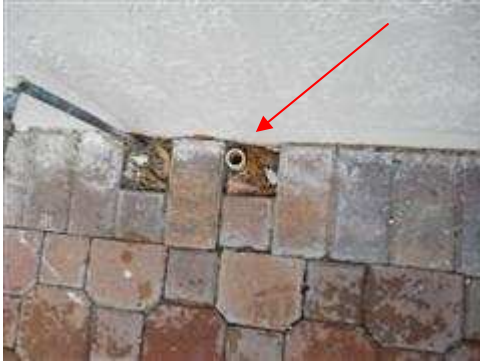
Uncapped drain line observed at rear patio.

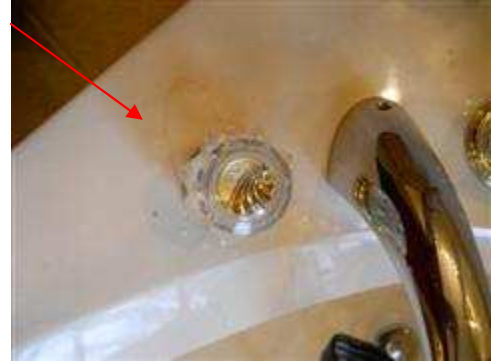
Hot water faucet was leaking at the master bathroom tub.

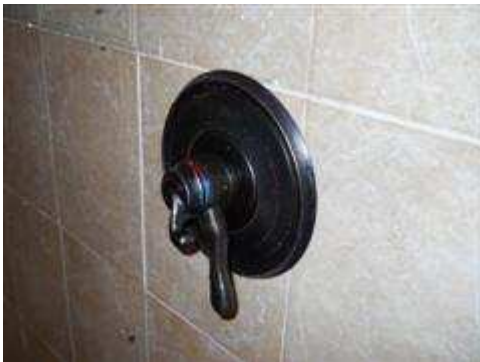
Shower handle in master bathroom was backwards (hot is required to be on the left side).

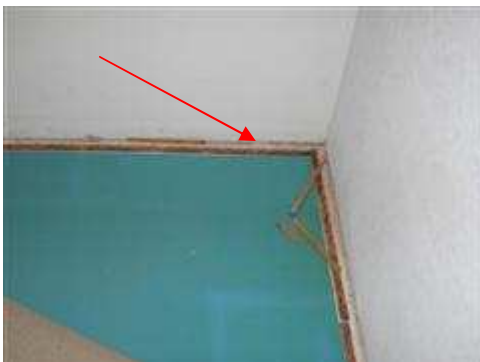
Staining observed at master bedroom closet behind air handler.

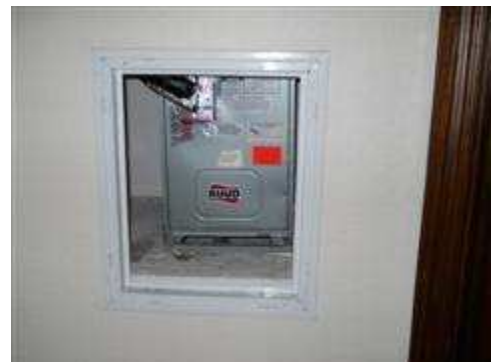
The air handler in the master bedroom was not readily accessible.

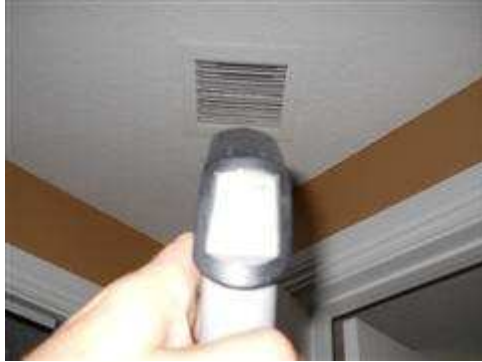
The master bedroom a/c did not cool.

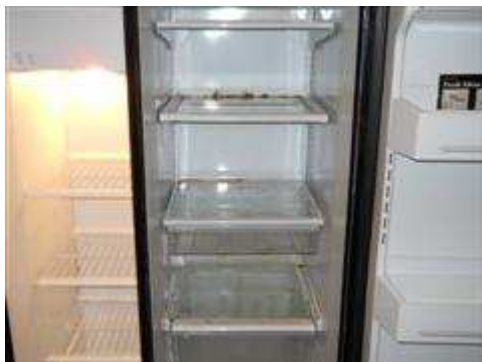
Interior of refrigerator was covered with fungus and ice maker was not operating long enough to test properly. If the unit cannot be sanitized, replacement is recommended.

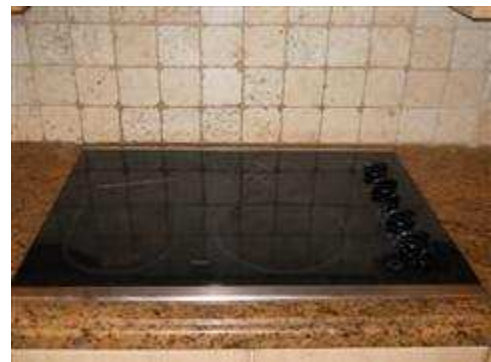
Cook top glass was broken.

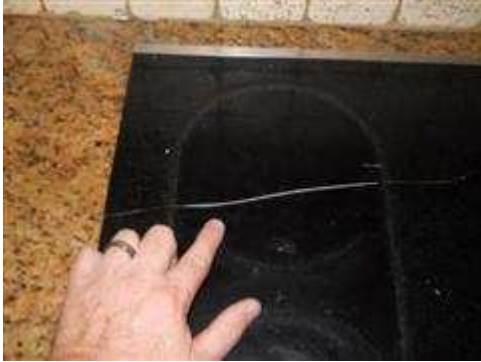
Cook top glass was broken.

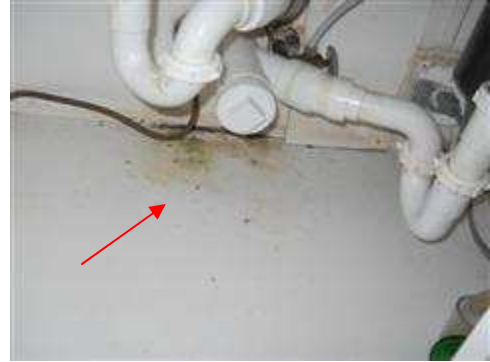
Shelf under kitchen sink was damaged.

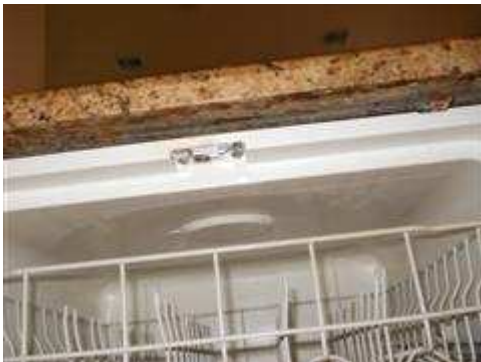
Dishwasher was not mounted and was not tested.

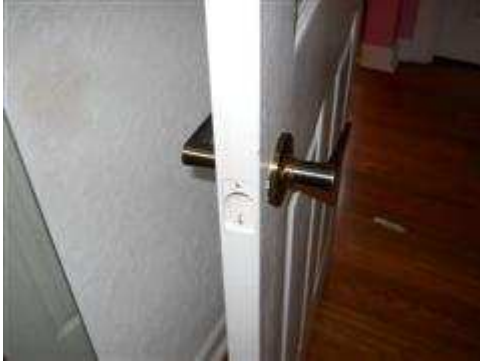
Door to left side bathroom was missing hardware.

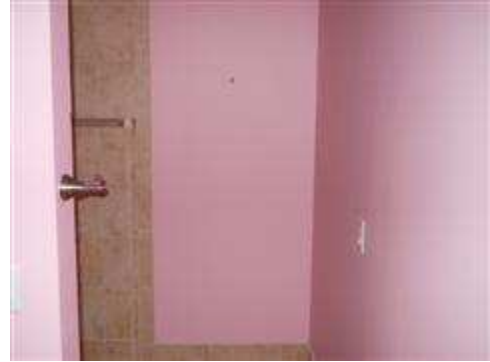
Note: It appears as though there may have been a pass-through to the rear exterior bathroom from the left rear bathroom.

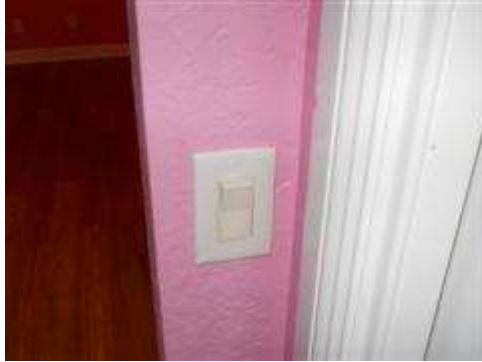
Switch was broken in left rear bedroom.

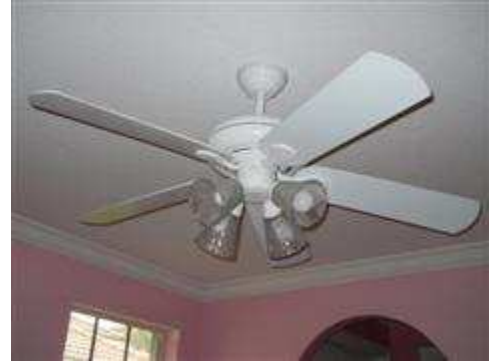
Fan did not function in left rear bedroom.

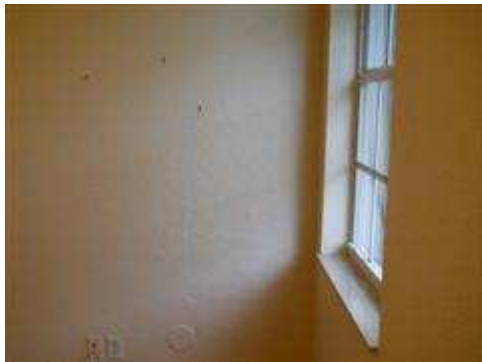
Improper repair observed at left bedroom wall behind shower.

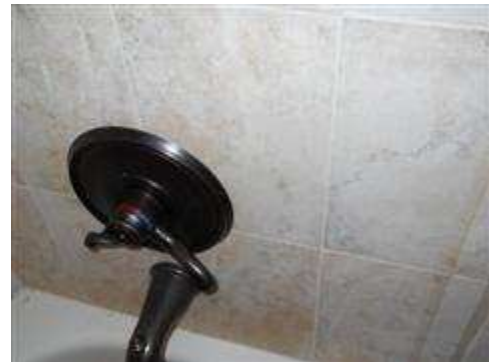
Shower handle in left side middle bathroom had no stopping point.

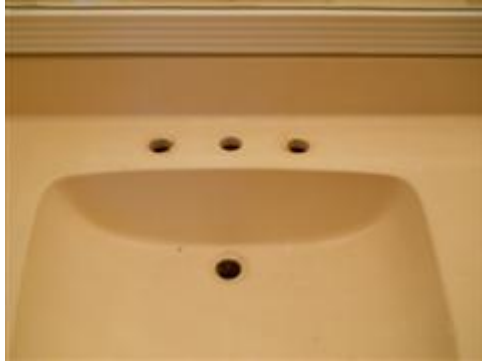
Faucets and drain lines were not present at left side middle bathroom.

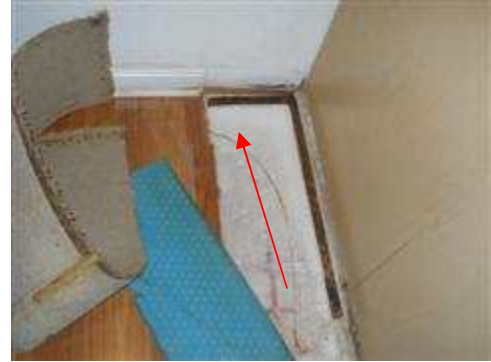
Damaged wall/baseboard observed in left side closet.

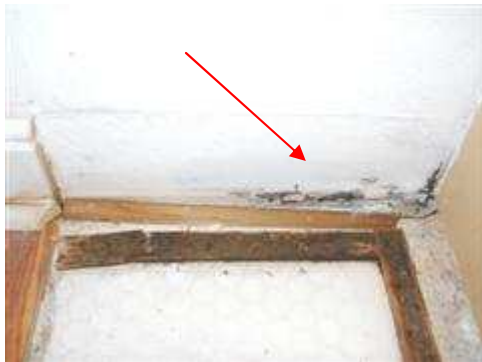
Damaged wall/baseboard observed in left side closet. Fungus was present as well.

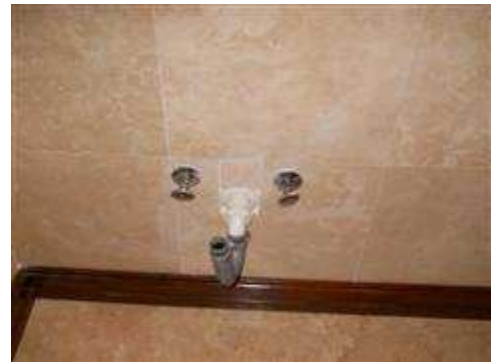
Sink was not present in left side half bathroom.

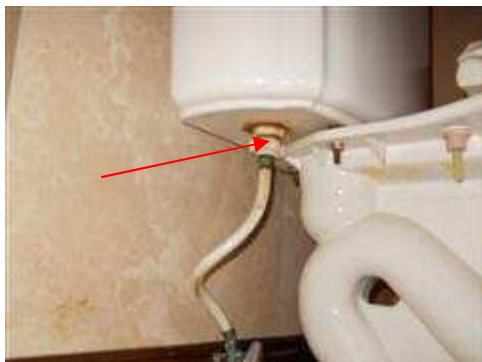
Toilet was leaking at left side half bathroom from bowl tank gasket and feed line.

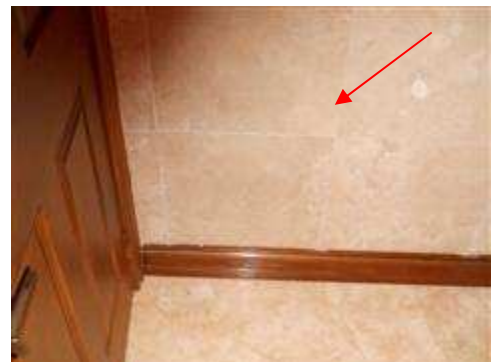
Tiles were damaged and loose at left side half bathroom wall.

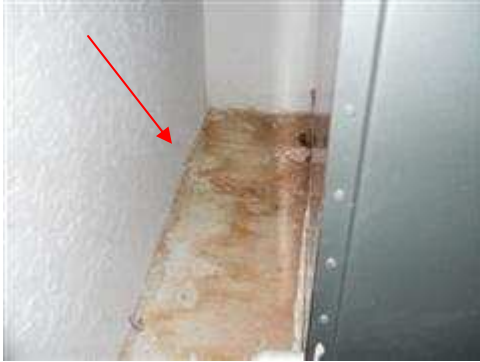
Shelf/box for left side air handler was damaged.

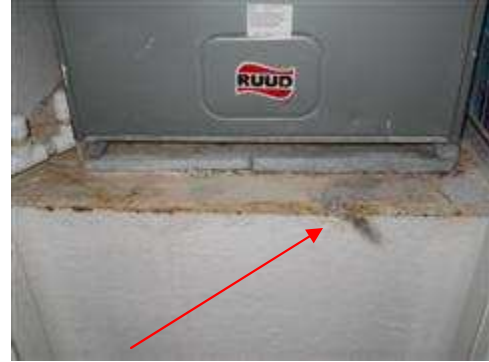
Shelf/box for left side air handler was damaged. Fungus was present as well.

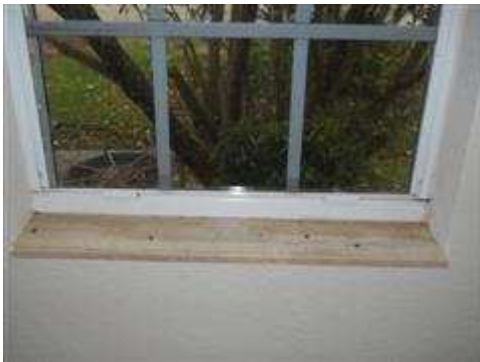
There were several dead bees present in the left side bedroom .

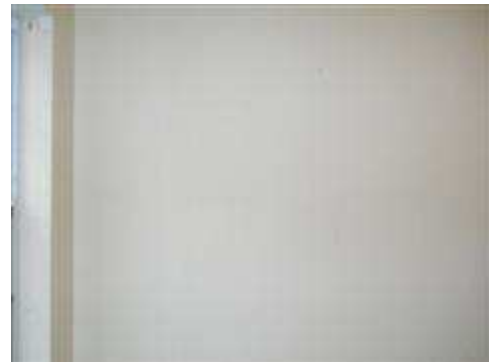
Staining/repairs observed at left bedroom wall.

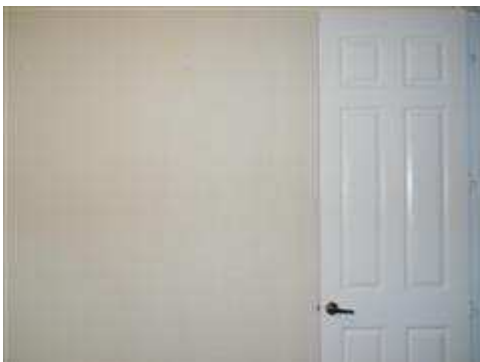
Staining/repairs observed at left bedroom wall.

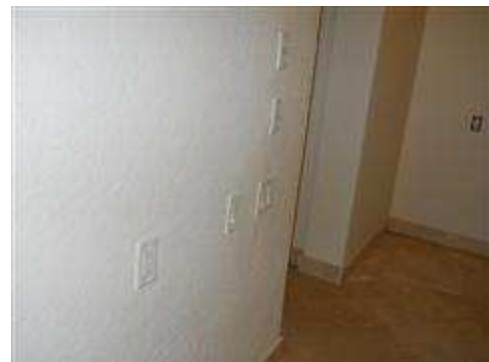
The hall between the garage and the rest of the home appears to be installed over a wood deck.

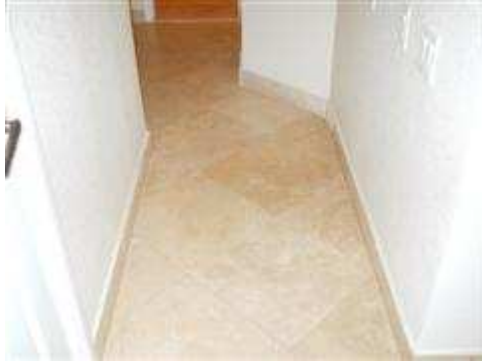
The hall between the garage and the rest of the home appears to be installed over a wood deck. Several tiles were loose in this area.

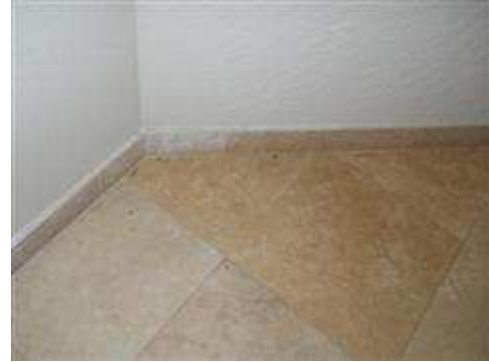
The hall between the garage and the rest of the home appears to be installed over a wood deck. Several tiles were loose in this area.

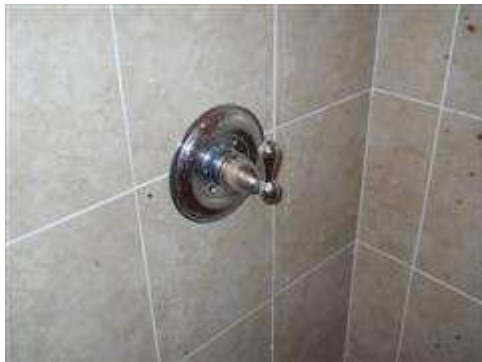
Shower handle in the "addition" bathroom was leaking.

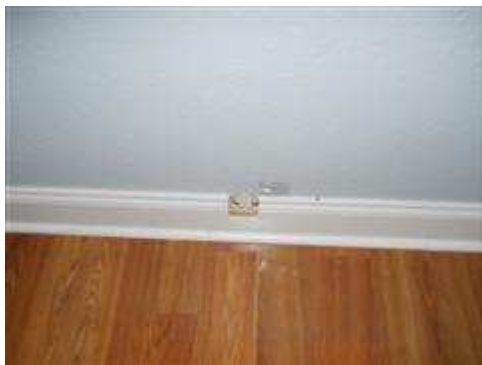
Cleanout was not installed properly for the addition bathroom.

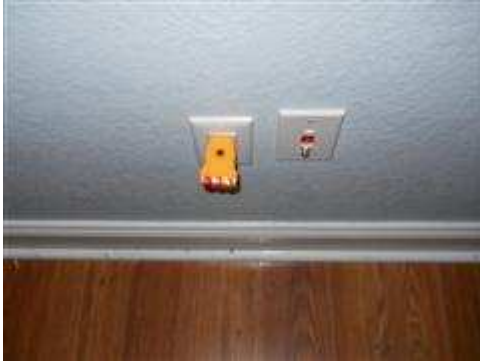
Receptacle in the addition bedroom showed reverse polarity.

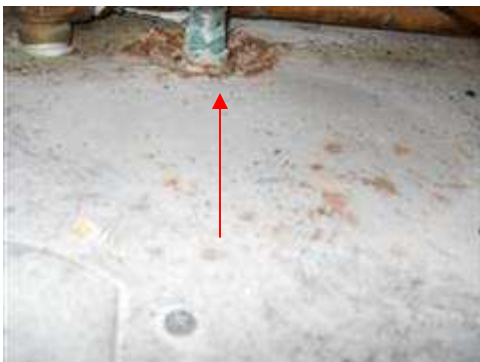
The water heater was rusted out at the inlet lines.

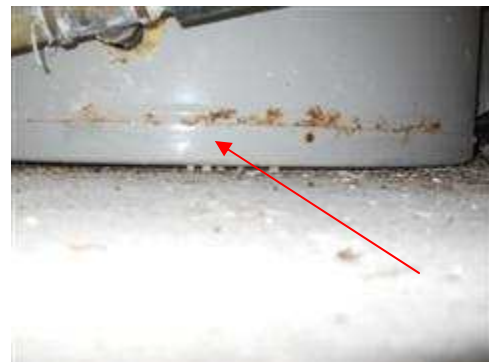
The base of the water heater was rusted out.

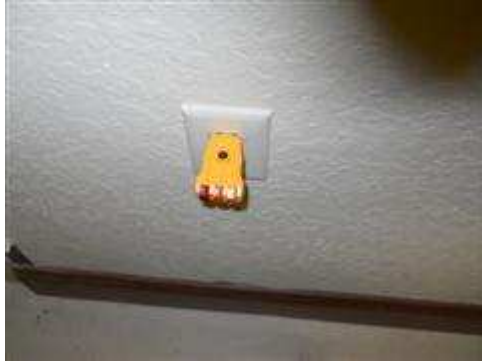
Receptacles in garage were not G.F.I. protected.

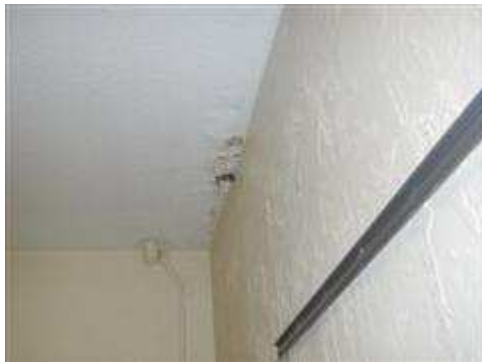
Damaged ceiling observed in garage from active roof leak.

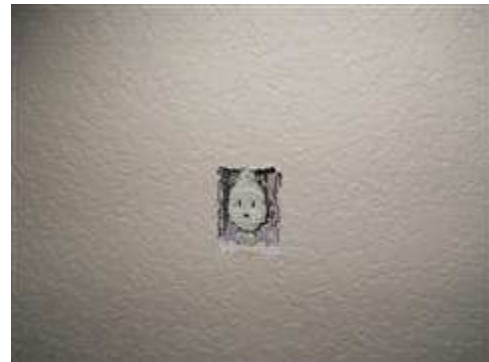
Face plate was not present at receptacle in garage hall exposing wiring.

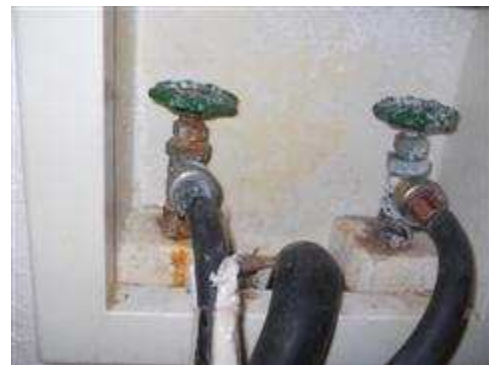
Shut off valves were leaking at washing machine.

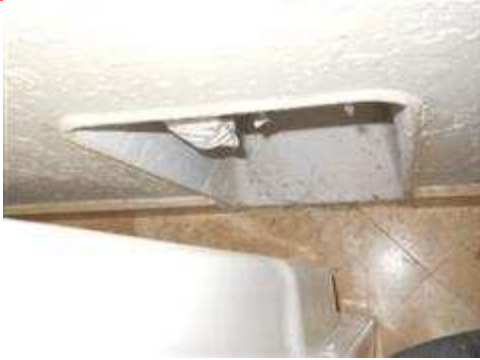
Dryer lint line was not attached to dryer.

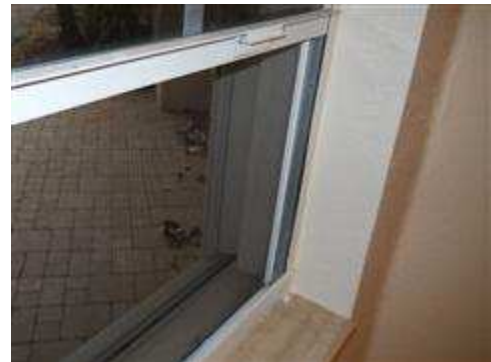
Spring was broken at dining room window.

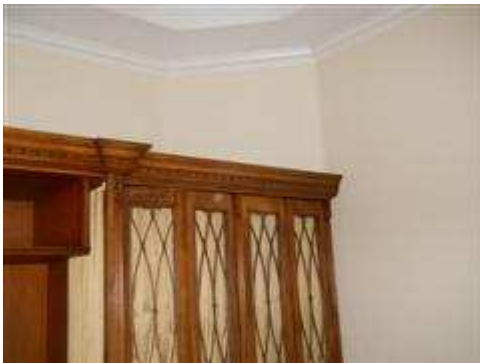
Master bedroom window was dry-walled over.

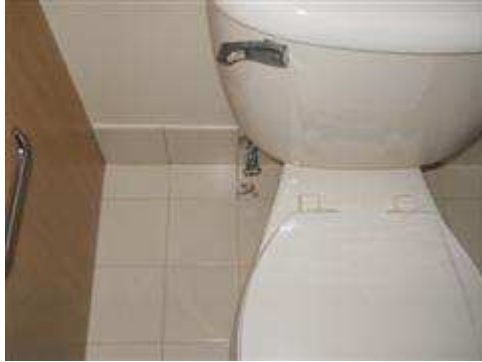
Shut off valve for upstairs toilet was leaking. Toilet was loose at floor with a possible damaged wax ring.

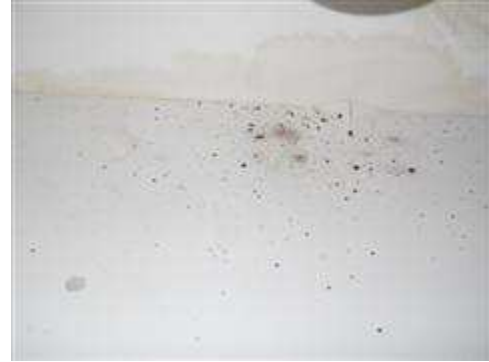
Vanity in upstairs bathroom was damaged.

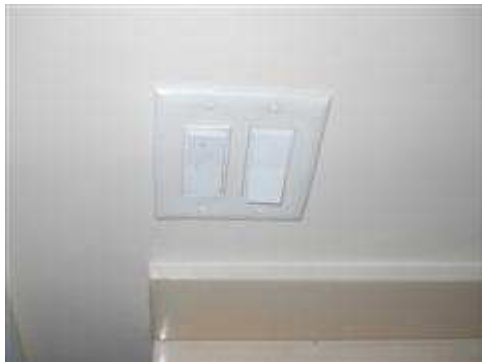
Switch was broken in upstairs bathroom.

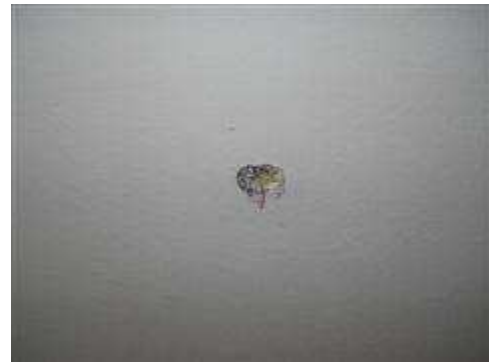
Light fixture was not present in the upstairs bedroom exposing wiring.

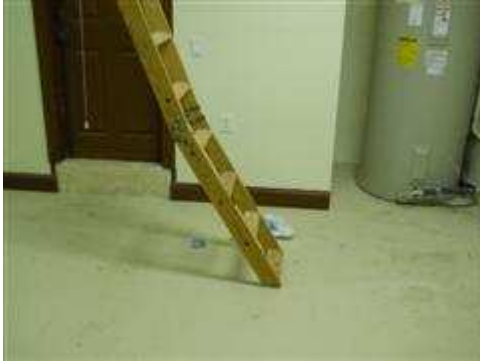
Attic access staircase in garage was installed improperly.

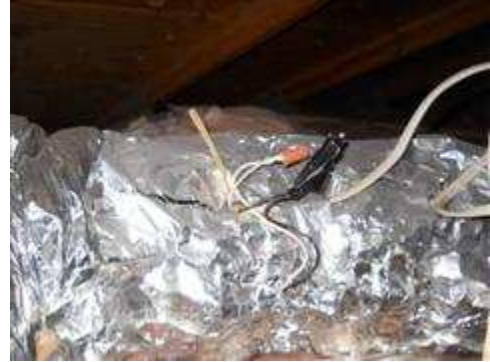
Open junction observed at garage attic for inline fan for the addition bedroom duct work, which did not shut off.

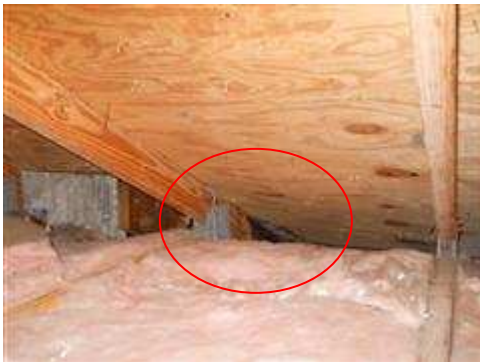
Roof leak observed at garage with damaged decking.

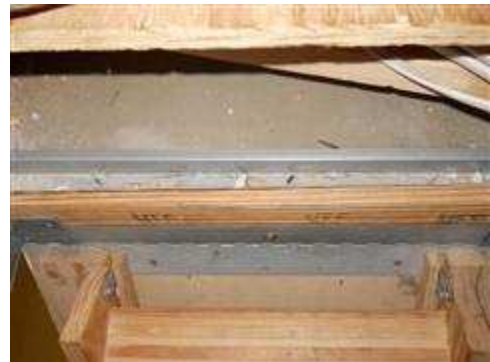
Attic access staircase in garage was installed improperly.

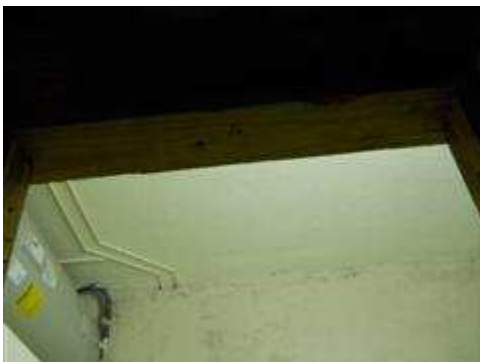
Attic access staircase in garage was installed improperly.

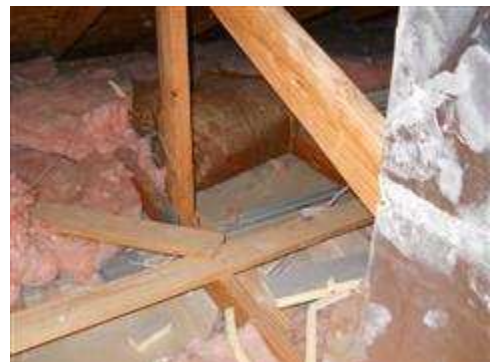
Insulation has been disturbed/improperly installed in several areas of the attics.

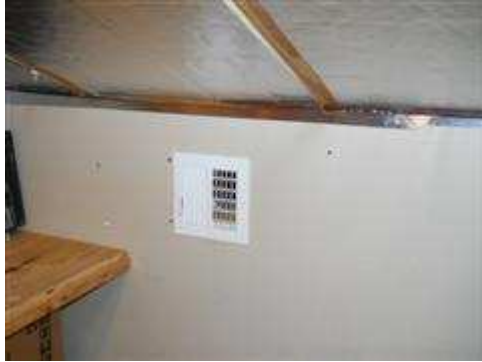
The attic has been modified into some type of living space which may not be permitted as per the local building code.

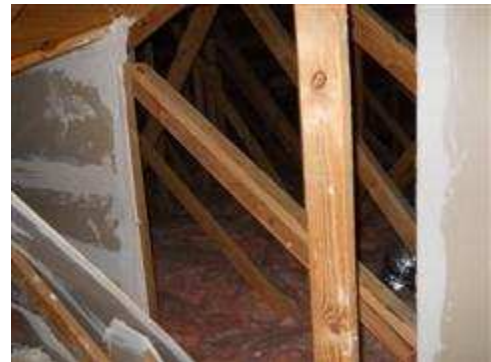
The separation wall in the attic between the master bedroom and the living room was damaged.

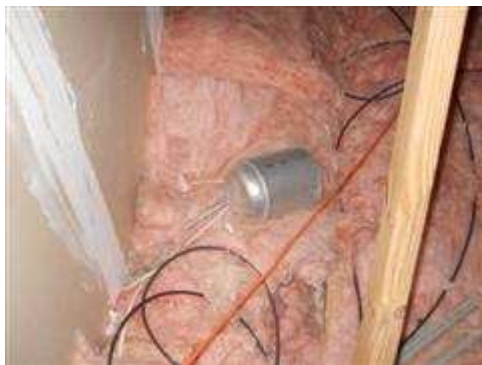
There were several high-hat lights that appeared to be functional laying on the attic floor.

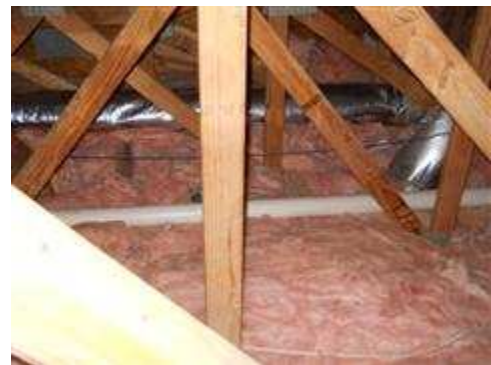
Insulation has been disturbed/improperly installed in several areas of the attics.

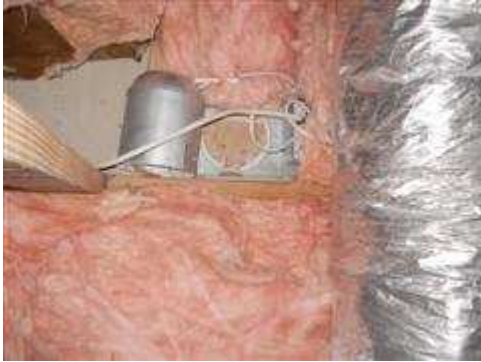
There were several high-hat lights that appeared to be functional laying on the attic floor.

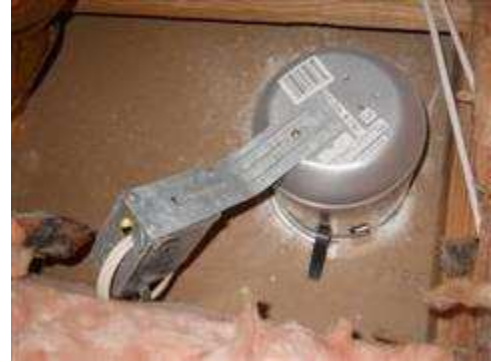
Improper connection observed at master bedroom high-hat light.

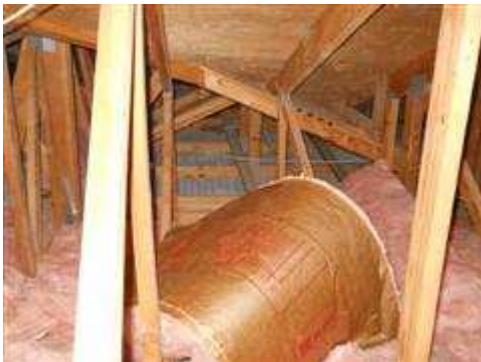
Insulation has been disturbed/improperly installed in several areas of the attics.

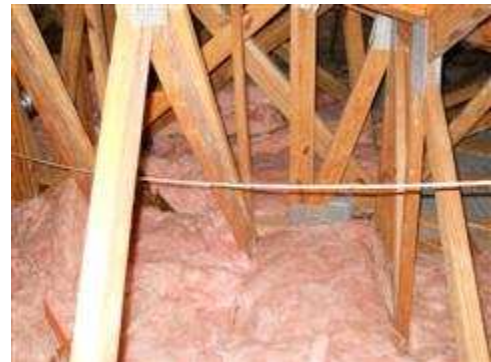
Insulation has been disturbed/improperly installed in several areas of the attics.

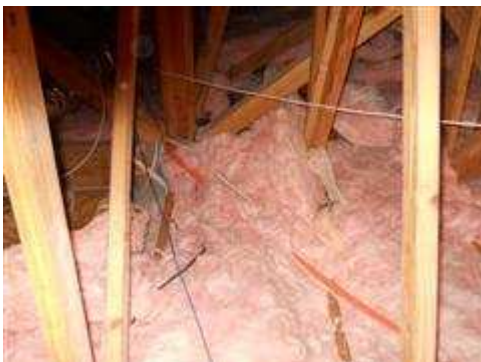
Insulation has been disturbed/improperly installed in several areas of the attics.

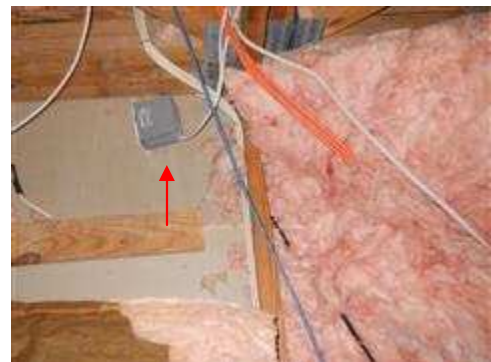
Un-mounted junction box, possibly a light switch observed in the attic.

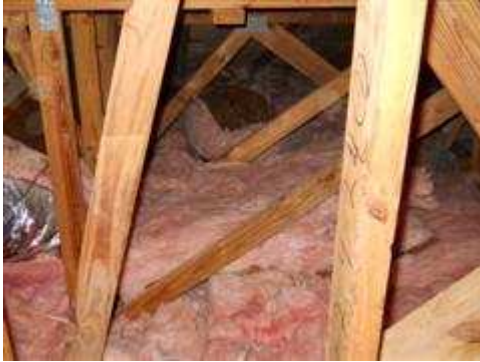
Insulation has been disturbed/improperly installed in several areas of the attics.

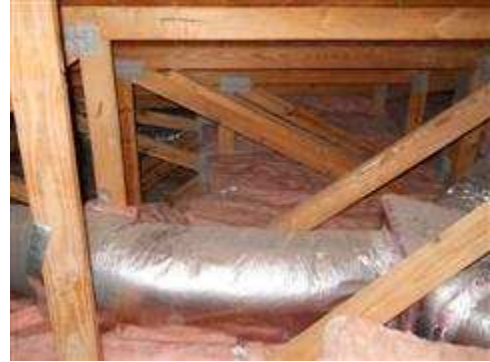
Insulation has been disturbed/improperly installed in several areas of the attics.

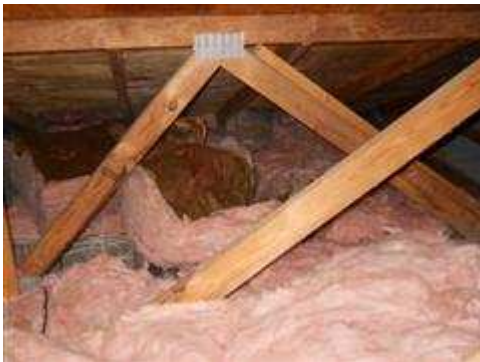
Insulation has been disturbed/improperly installed in several areas of the attics.

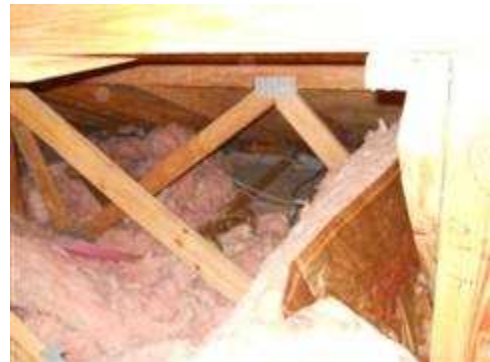
Insulation has been disturbed/improperly installed in several areas of the attics.

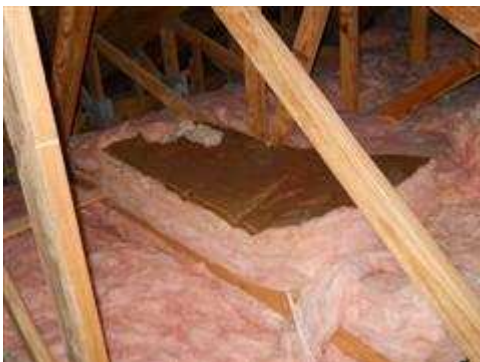
Insulation has been disturbed/improperly installed in several areas of the attics.

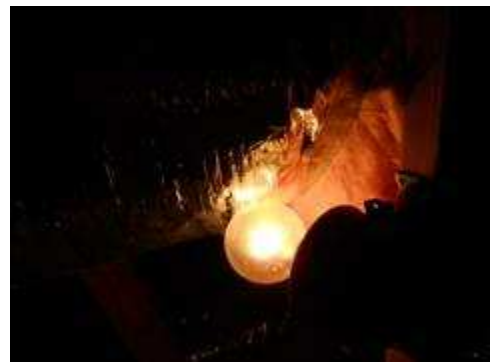
Duct line above master bedroom closet is directly over the attic light fixture.

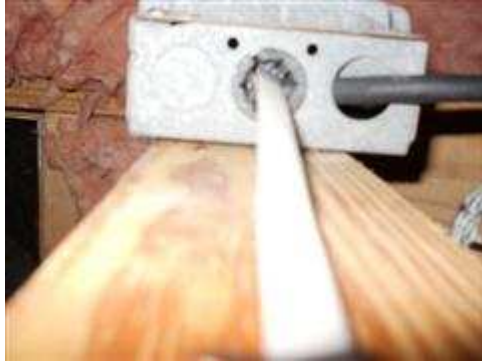
Improper junction observed at attic light switch box.

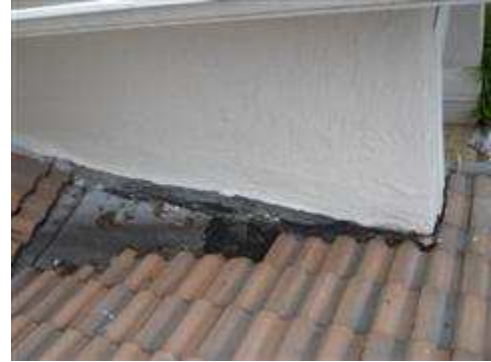
Deteriorated roof covering observed at transition between the second story and the first story roof.

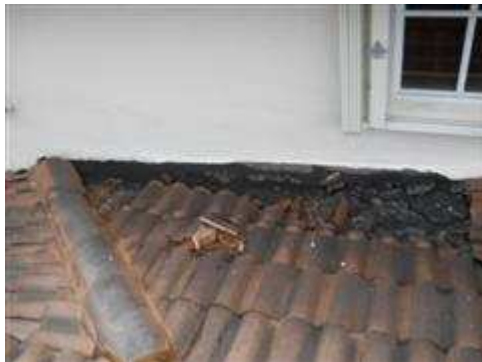
Deteriorated roof covering observed at transition between the second story and the first story roof.

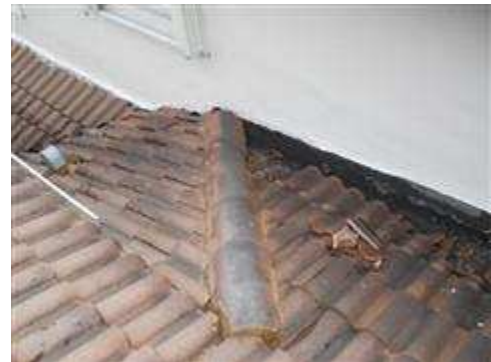
Deteriorated roof covering observed at transition between the second story and the first story roof.

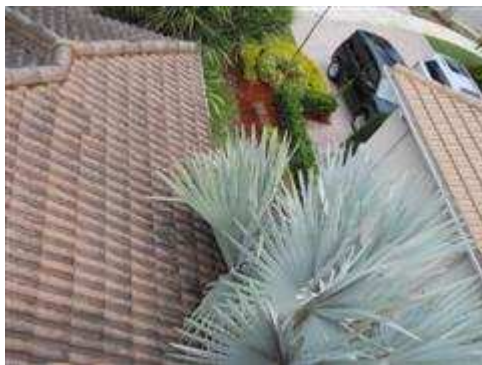
Tree at the left side of the home was up against the house and interfering with the roof.

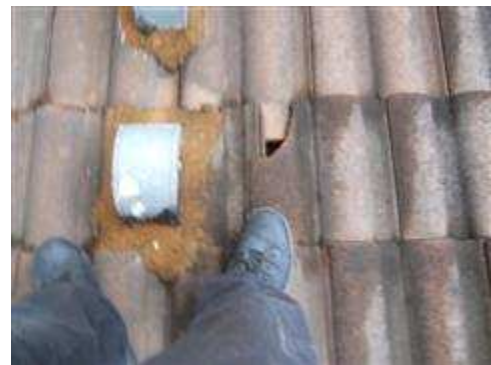
Broken tiles observed on main roof.

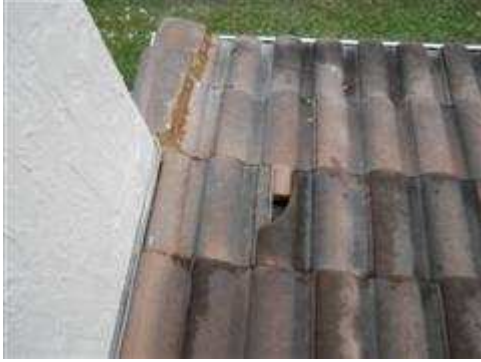
Broken tiles observed on main roof.
