[www.magnuminspections.com](http://www.magnuminspections.com)

Phone: (954) 340-6615

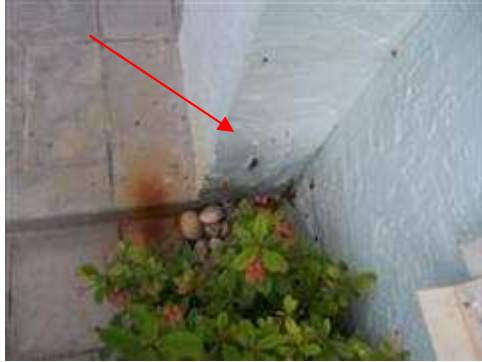
Damaged stucco observed at front entrance.

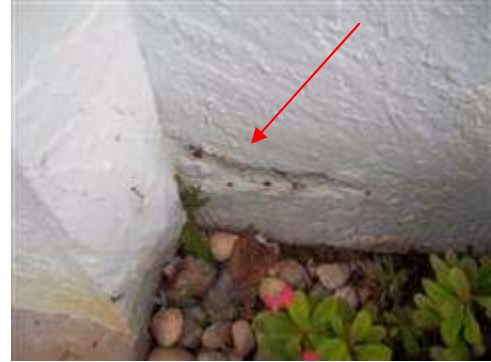
Damaged stucco observed at front entrance.

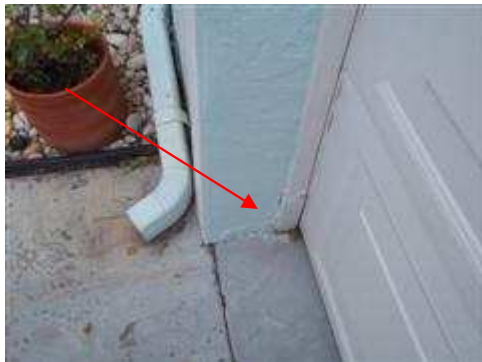
Main garage door trim was damaged at both sides.

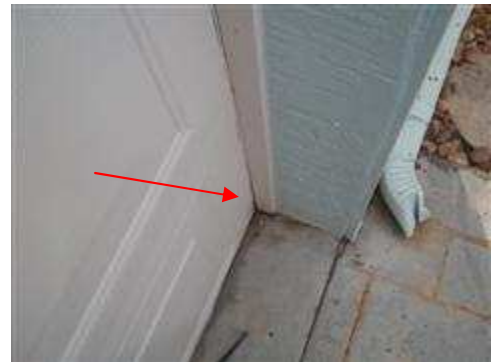
Main garage door trim was damaged at both sides.

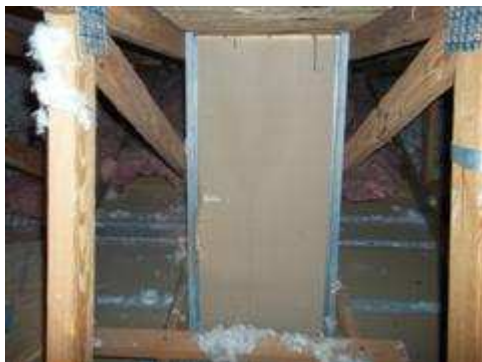
Insulation was not present at skylight and surrounding areas of attic.

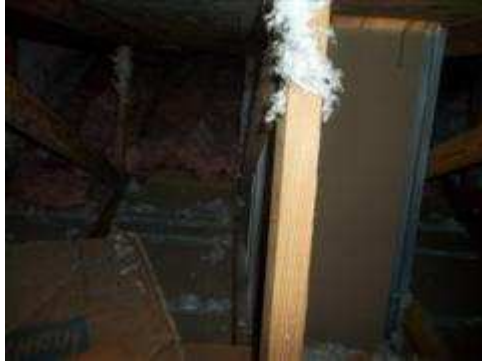
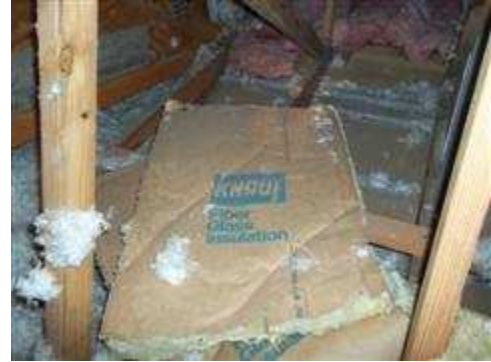
Insulation was not present at skylight and surrounding areas of attic. Insulation was not present at skylight and surrounding areas of attic.

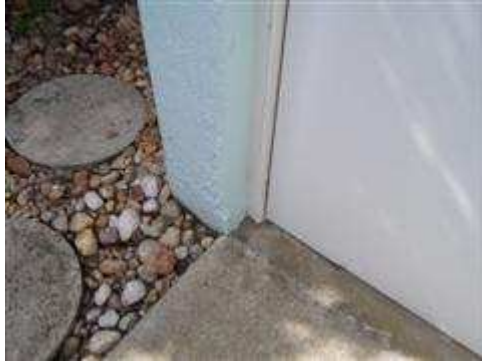
Rear garage door and frame were rotted (replace).

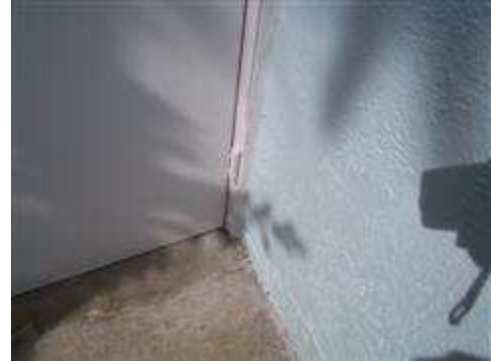
Rear garage door and frame were rotted (replace).

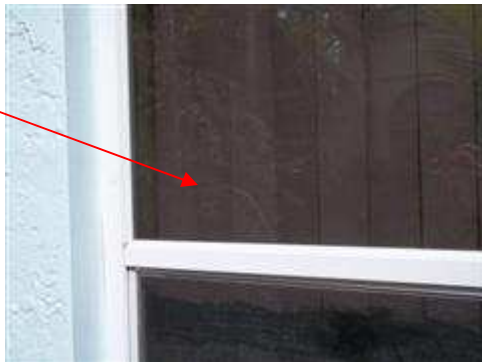
Right side window had cracked glass.

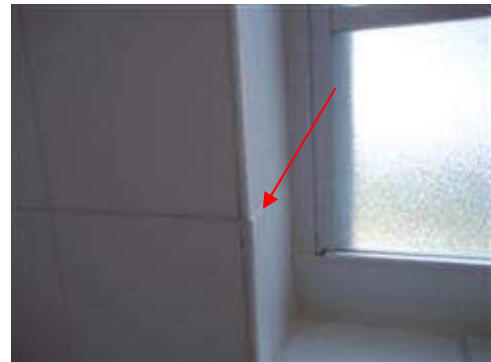
Tiles in hall bathroom shower around window were missing grout.

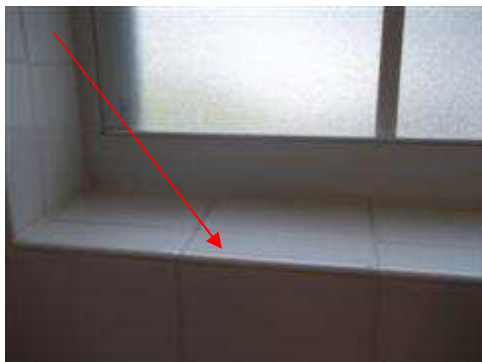
Tiles in hall bathroom shower around window were missing grout.

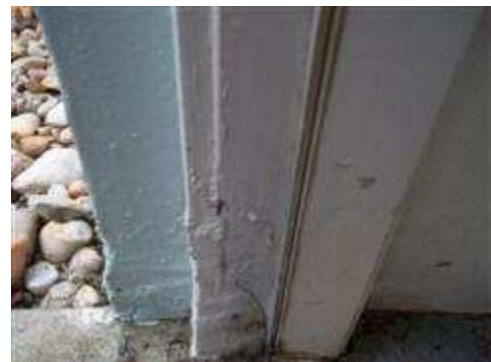
Rear garage door and frame were rotted (replace).

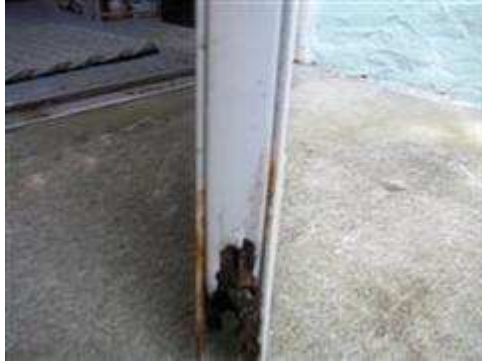
Rear garage door and frame were rotted (replace).

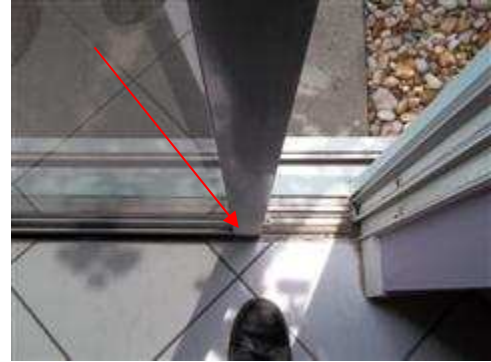
Rear sliding glass door did not operate properly. The door makes contact with the frame which has been pushed out by the tile grout.

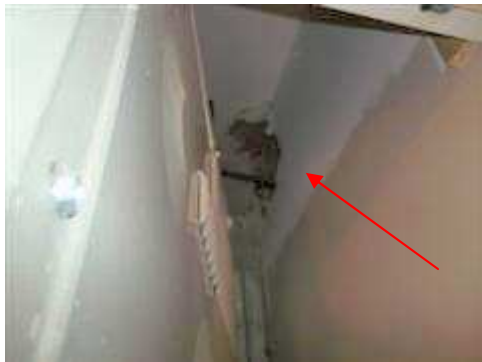
Damaged wall exposing plumbing connections at kitchen viewed when the stove was moved.

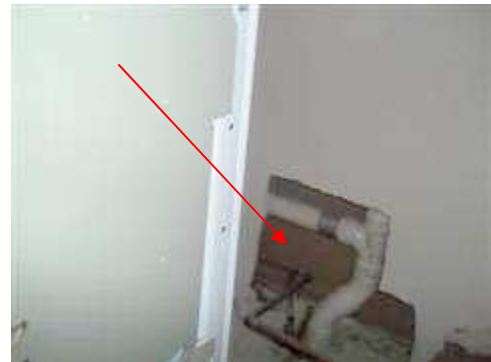
Damaged wall exposing plumbing connections at kitchen viewed when the stove was moved.

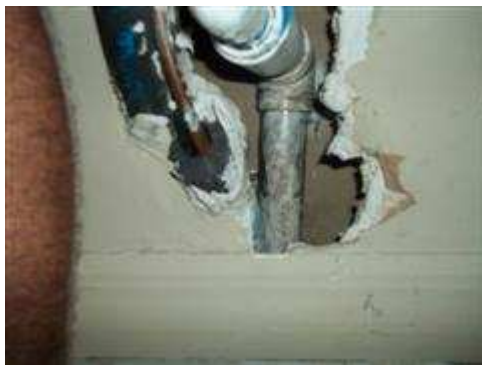
Damaged wall observed in air handler closet.

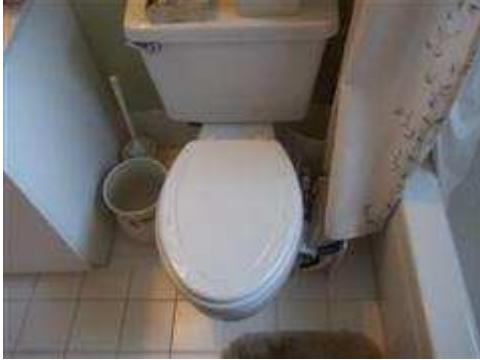
Toilet was loose at floor with probable damaged wax ring in hall bathroom.

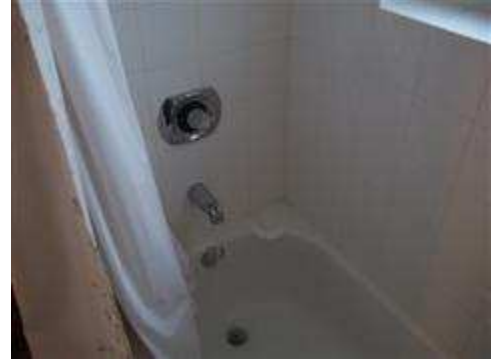
Water was coming out of the shower and tub spout in the hall bathroom at the same time.

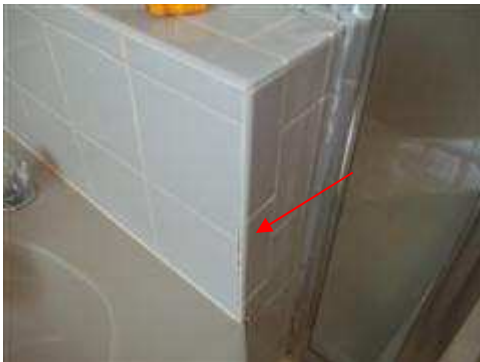
Tiles were loose at interior and exterior master bathroom shower walls with missing grout.

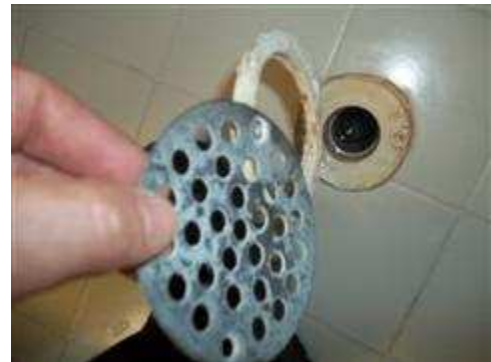
Shower drain assembly was not attached in the master bathroom.

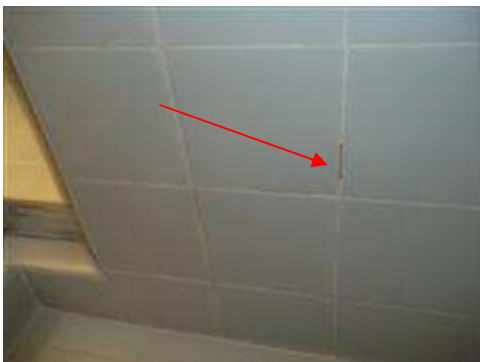
Tiles were loose at interior and exterior master bathroom shower walls with missing grout.

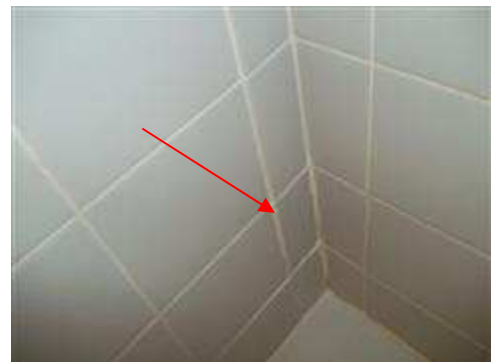
Tiles were loose at interior and exterior master bathroom shower walls with missing grout.

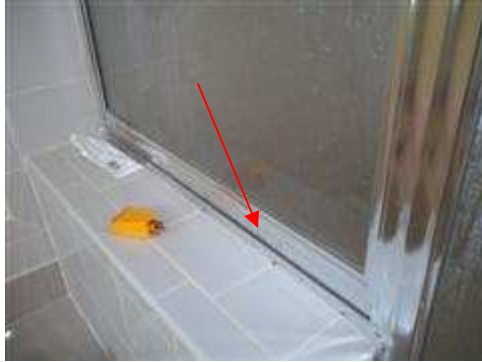
Shower was leaking through the rear glass and down the tiles in the master bathroom.

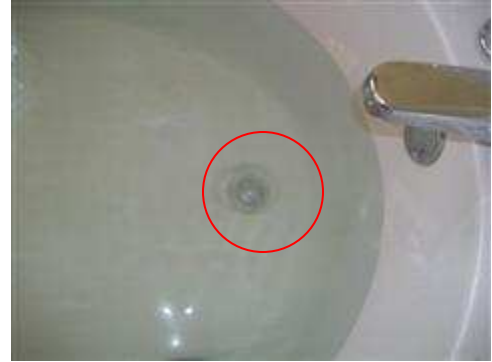
Drain stopper in master bathroom tub did not seal properly.

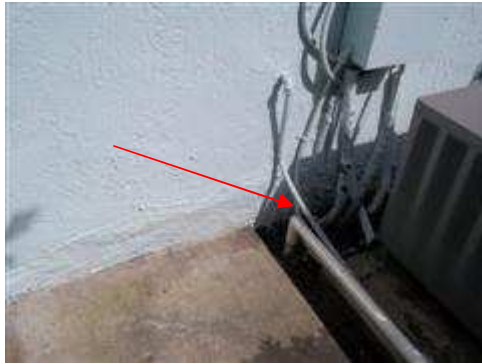
Electrical wiring for a/c condensing unit was not secured properly.

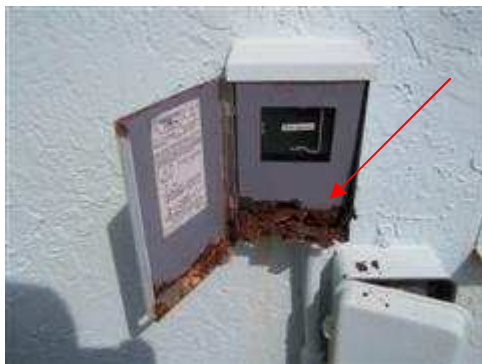
Service disconnect box for pool equipment was rusted out.

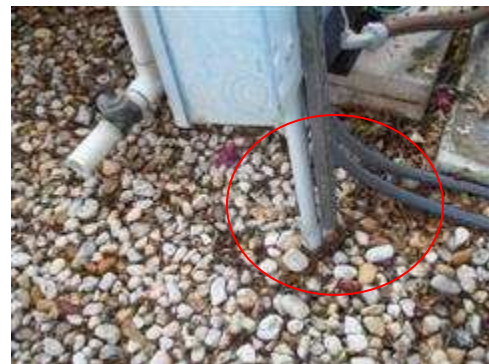
Support post for pool equipment was rusted out and conduit was damaged.

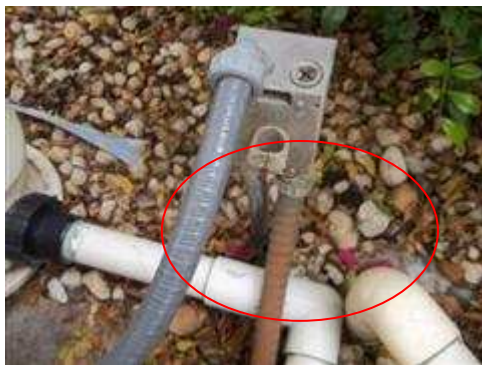
Support post for pool equipment was rusted out .

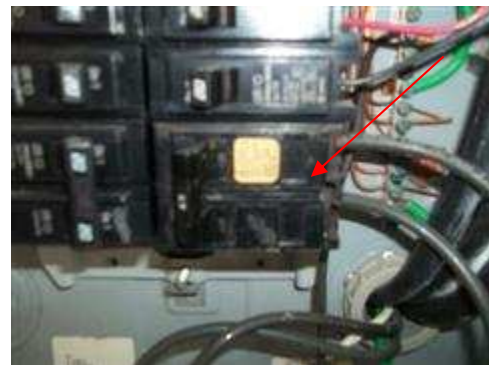
There was another manufacturers breaker present in the Challenger panel. Most manufacturers do not allow this.

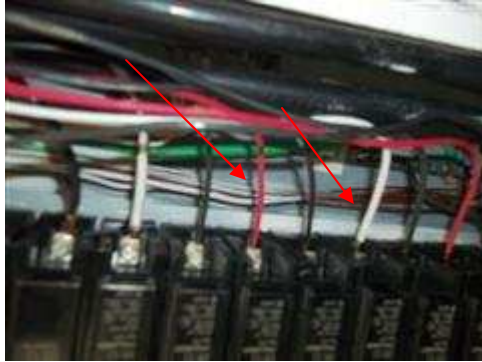
Paint was observed on the buss-bar at the garage panel.

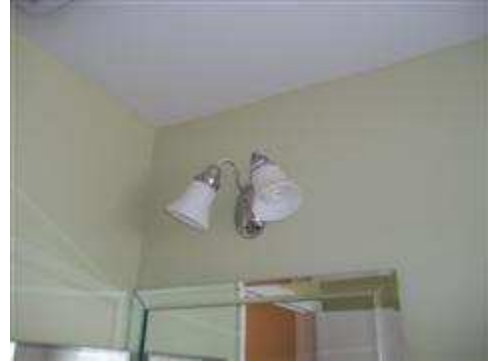
Light in hall bathroom shut off when the G. F. I. receptacle was tripped.

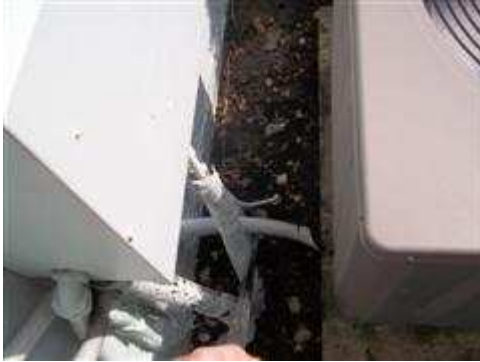
Heat recovery system has been disconnected from the air conditioner. (removal is recommended).

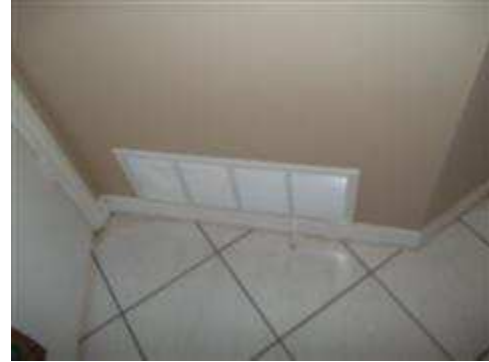
An auxiliary intake was installed in the laundry room and the wall voids were not sealed allowing air from that area to be drawn into the system.

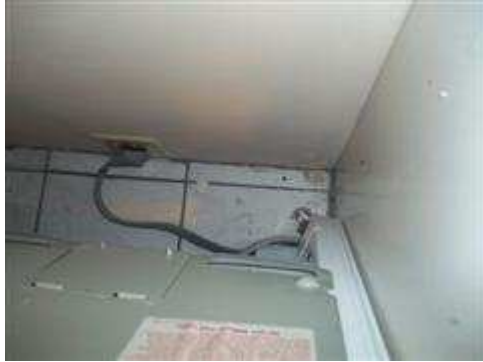
Anti-tip bracket was not present at range.

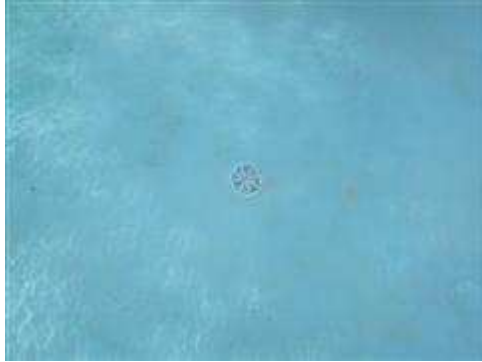
Improper drain grate observed in pool.

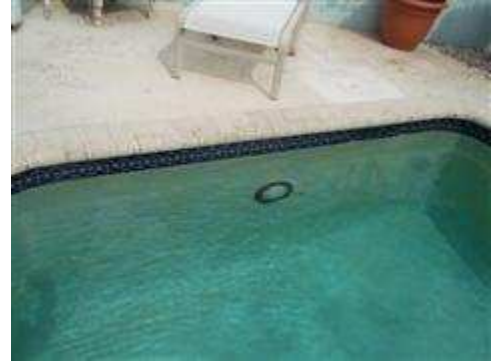
Pool light ring was rusted.

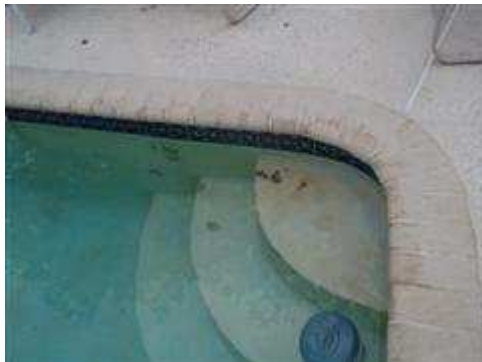
There were numerous areas of the pool coating which were deteriorating exposing the pool shell and in some instances, the pool wire/rebar.

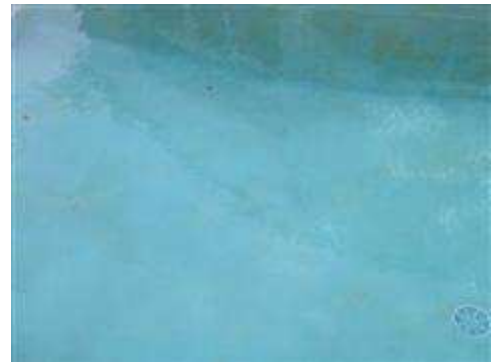
There were numerous areas of the pool coating which were deteriorating exposing the pool shell and in some instances, the pool wire/rebar.

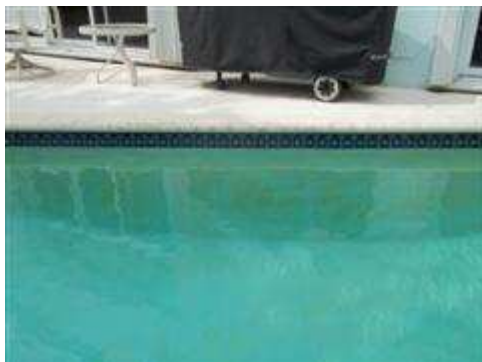
There were numerous areas of the pool coating which were deteriorating exposing the pool shell and in some instances, the pool wire/rebar.

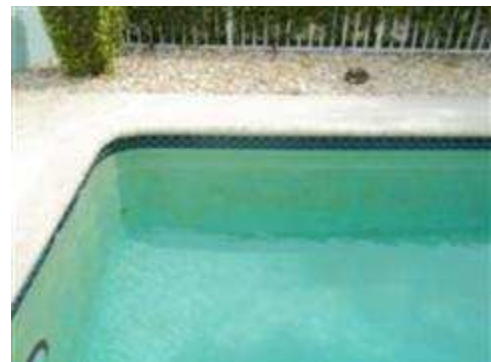
There were numerous areas of the pool coating which were deteriorating exposing the pool shell and in some instances, the pool wire/rebar.

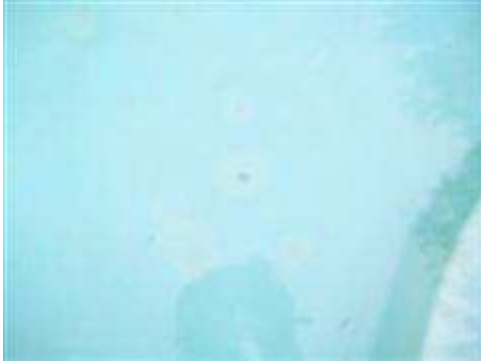
There were numerous areas of the pool coating which were deteriorating exposing the pool shell and in some instances, the pool wire/rebar.

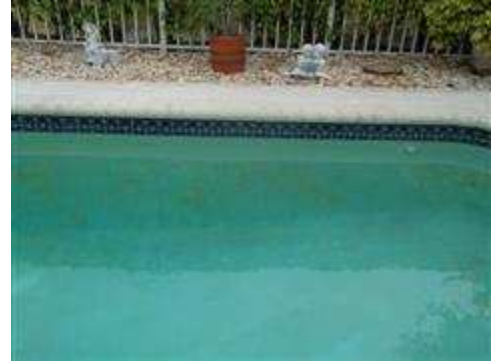
There were numerous areas of the pool coating which were deteriorating exposing the pool shell and in some instances, the pool wire/rebar.

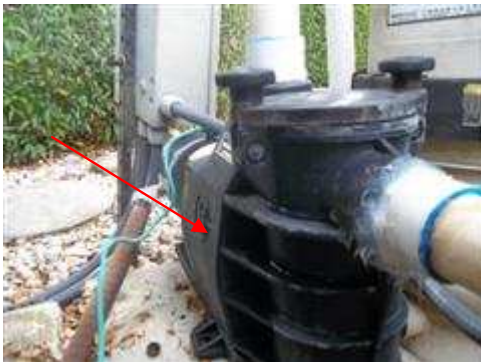
Leak observed at pool pump.

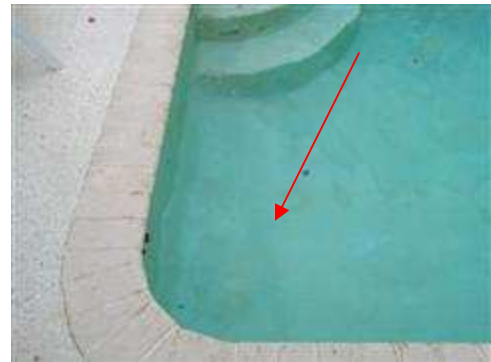
There were bubbles coming out of the pool returns which usually is an indication of air intrusion into the system.

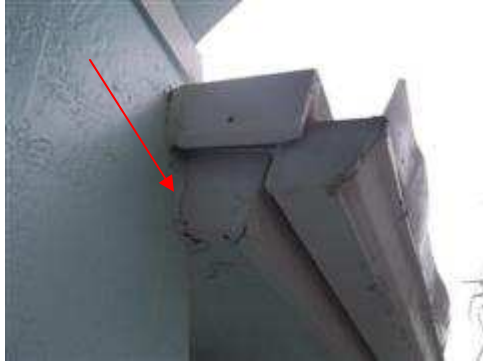
There were numerous areas of rotted fascia observed around the home.

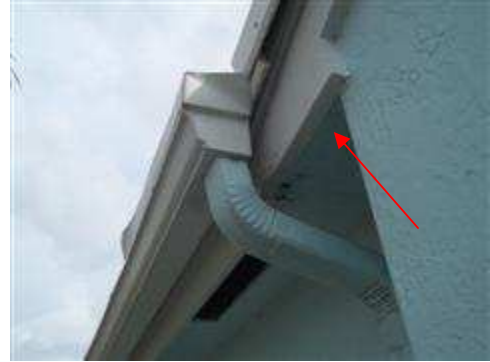
There were numerous areas of rotted fascia observed around the home.

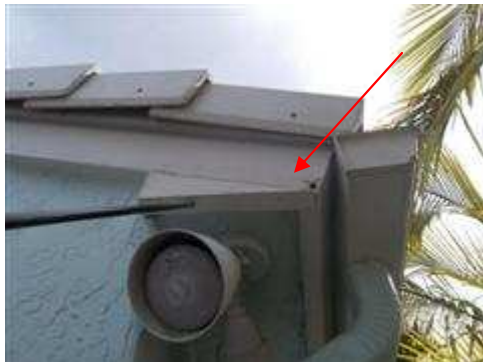
There were numerous areas of rotted fascia observed around the home.

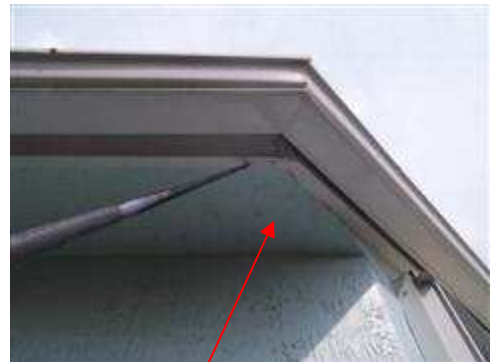
There were numerous areas of rotted fascia observed around the home.

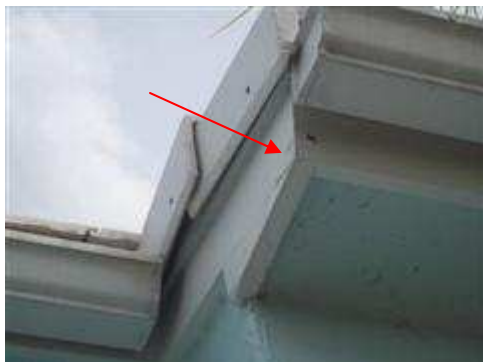
There were numerous areas of rotted fascia observed around the home.

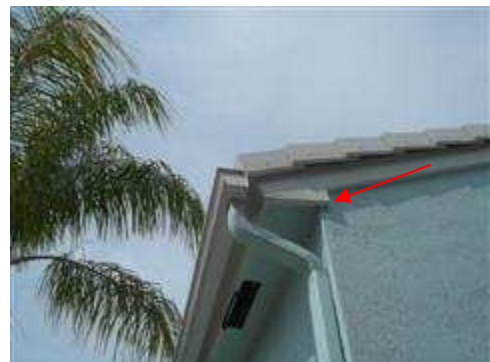
There were numerous areas of rotted fascia observed around the home.

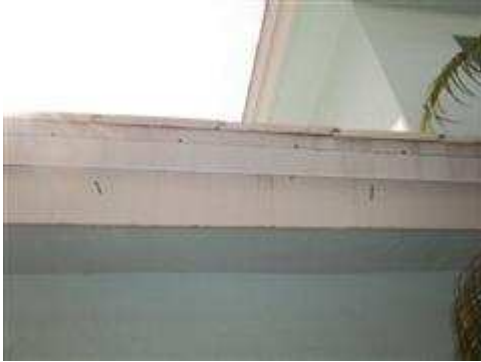
There were numerous areas of rotted fascia observed around the home.

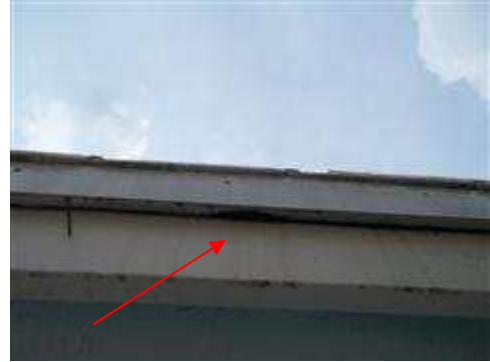
Damaged drip edge observed at left side of house.

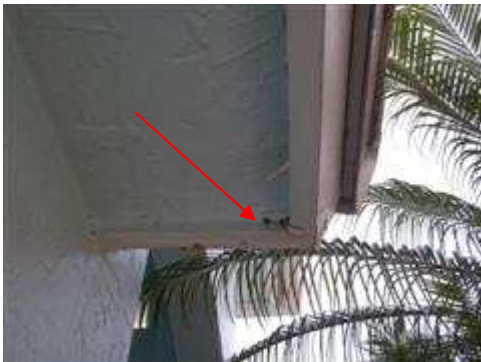
There were numerous areas of rotted fascia observed around the home.

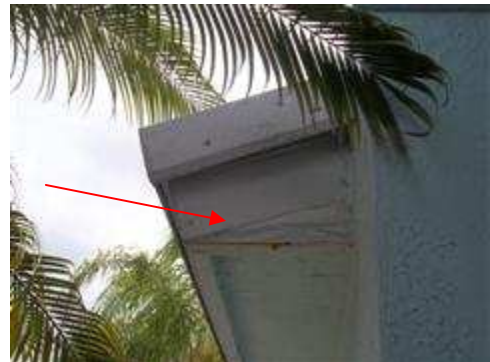
There were numerous areas of rotted fascia observed around the home.

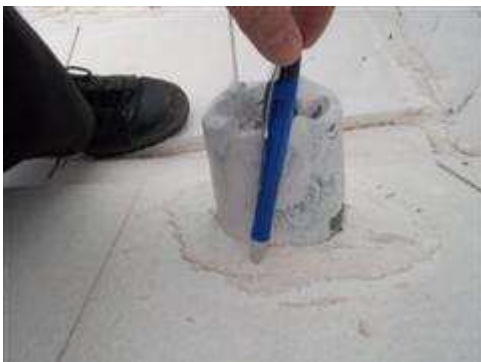
The vent stack at the front of the home was too low (six inches is the minimum height)

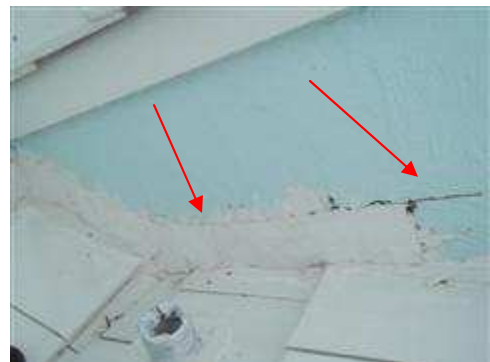
During the flashing replacement over the front entrance, the wall was not repaired properly.

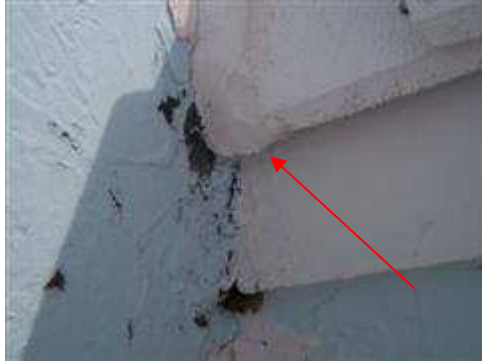
Damaged fascia observed at front entrance on second level of the roof.

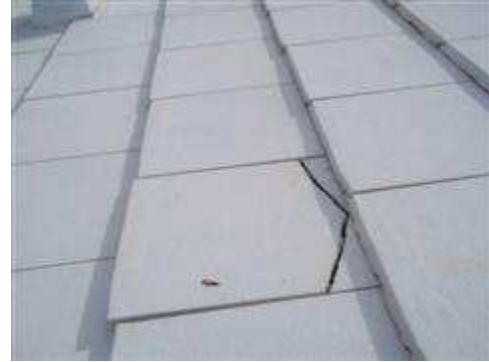
Broken roof tile observed on main roof.

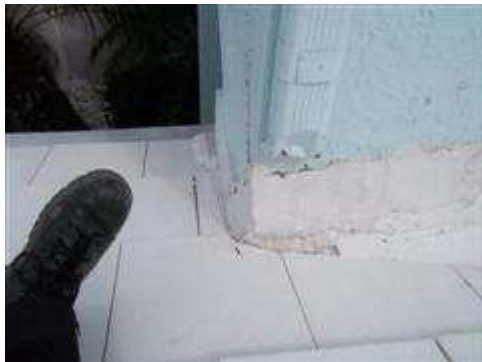
Upper level gutter downspout was not present and water has washed away the cement on the lower portion of the roof. Over time, this will most likely turn into a roof leak.

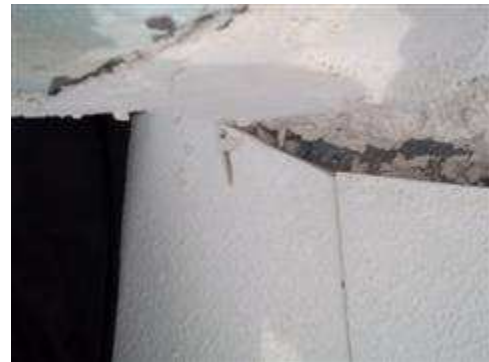
Upper level gutter downspout was not present and water has washed away the cement on the lower portion of the roof. Over time, this will most likely turn into a roof leak.
